SCAN TOOLS, O-SCOPES AND TOOTHPICKS

Comprehensive PCM operating strategy outlines aren't written down anywhere, but it would help if they were.

A PREVIOUS GARAGE VEHICLE RETURNS

VEHICLE: 2000 Jeep Cherokee
MILEAGE: 86,453 miles
DRIVETRAIN: 4.0L engine, automatic transmission
COMPLAINT: "Sputters" while driving.

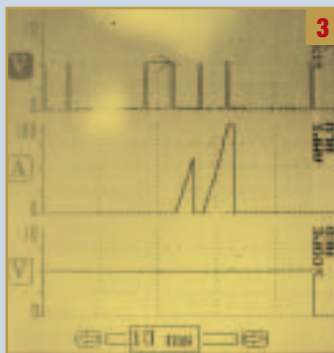
2. This Cam Position Counter pattern (center graph) eventually deteriorated and went completely flat, in spite of the fact that I had a good clean square wave signal present at the PCM terminal in question. To further complicate my thinking, this PCM did the same thing on my personal vehicle later that day.

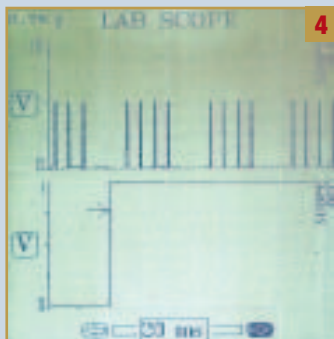
3. The top graph pattern on this oscilloscope is the crank sensor signal. Graph number two is a current ramp picture of what the PCM was doing with one of the primary circuits. The bottom trace is the cam signal. Pay close attention to where the cam signal is in relation to the crank signal on the top graph. The Jeep 4.0L flywheel ring has three sets of four holes spaced 120 degrees apart; thus, there are three groups of four like this in a complete revolution.

4. This is what the cam sync signal (bottom trace) should look like in relation to the crank signal. It should correspond with a point about halfway between two of the sets of four in the flat spot. I turned the cam synchronizer just like you'd turn a distributor to set the timing, but was watching the scope instead of a timing light.

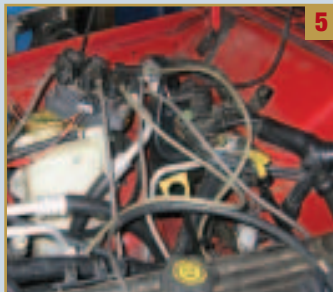
5. This was my "thinking outside the box" way of getting a secondary signal: Because I had already clipped the primary wires at the PCM and run a temporary overlay using a spare connector that would plug into the original coil rail, I simply put a different connector on that same overlay harness. I did some checking to find out which coil was which, plugged it into the Explorer's coil pack and fired the Jeep up on the Explorer's coil pack.

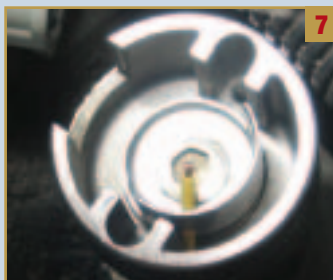
7. Whenever you're working on a Cherokee or a Grand Cherokee and you want to eliminate one possible cause of a peculiar drivability complaint, it doesn't cost much to put the crank on zero TDC compression and turn the cam synchronizer so the hole in the housing lines up with the hole in the vane, just as illustrated. After performing the scope procedure, I rolled the 4.0L to zero and found that these holes were perfectly aligned. I could have done this when the Jeep first arrived and fixed the problem, but I wouldn't have had such an interesting story to tell.

Normal timing chain stretch must have allowed the cam sensor to work itself slightly out of line, and the rest is history. It was a perfect match. I had gone through fire and flood all week long, and the whole time I could have fixed it with a toothpick. **ZZ**

Bringing the crankshaft around to zero degrees top dead center (TDC) compression, I removed the cam sensor and checked the hole in the vane where it was supposed to line up with the hole in the housing by inserting a toothpick through both holes. I've performed that operation dozens of times and never even thought about doing it on this Jeep because the cam synchronizer hadn't been touched for 47,000 miles. There is a utility in the DRB III scan tool for synchronizing the sensor, but I've found that the toothpick method works best – believe it or not.

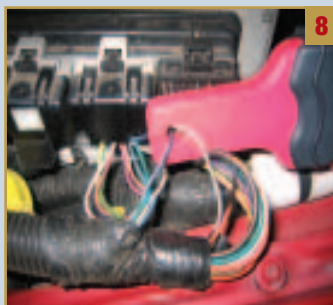
8. One more thing: If you want a nice parade pattern on your single-trace scope of either coil or injector current ramps on a problem engine, give this little trick a try. Run all the wires through the inductive lead, and the scope will sort them out across its time scale. This inductive probe is available from most automotive electronics tool suppliers for about \$150 and can be used with either an o-scope or a multimeter.
