Water leak from front cowl - 4/20/2003

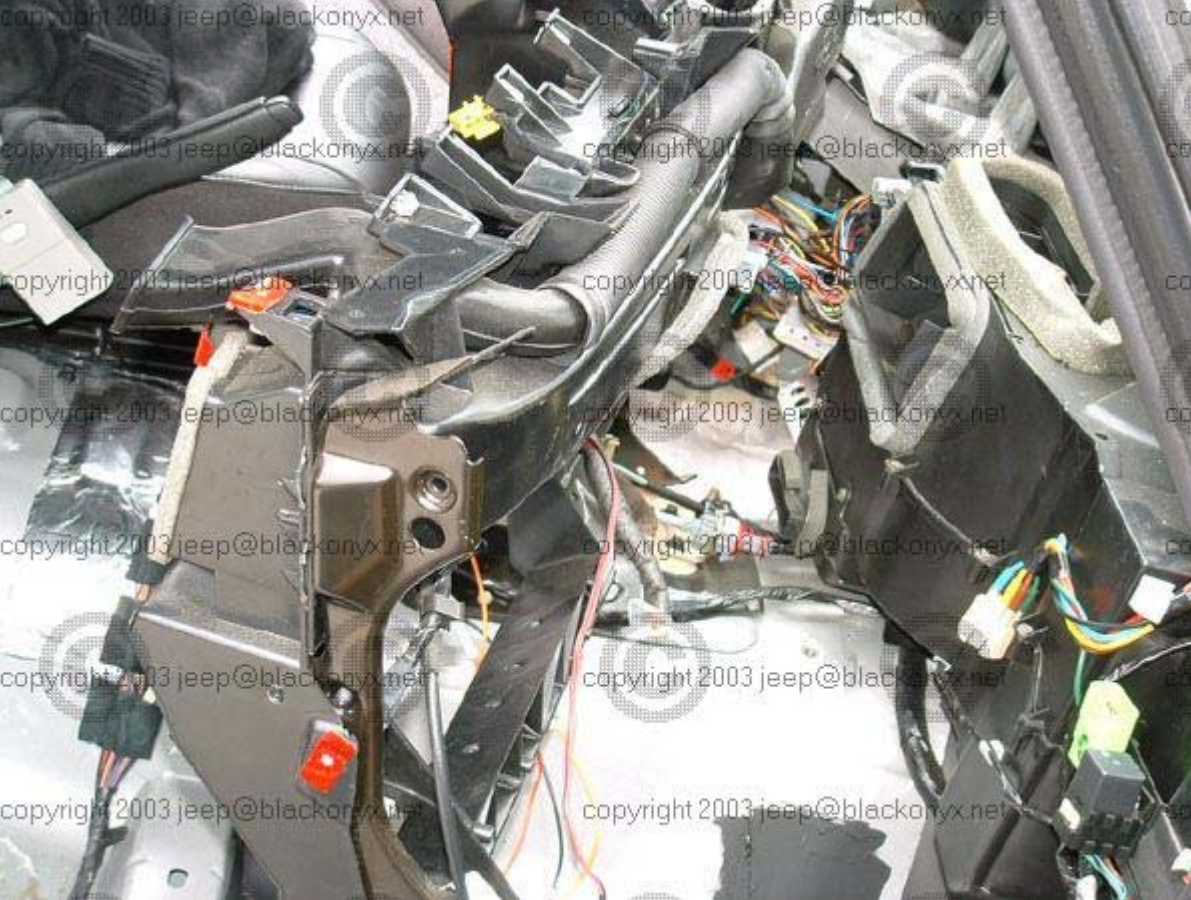
Dash pulled back from heater box

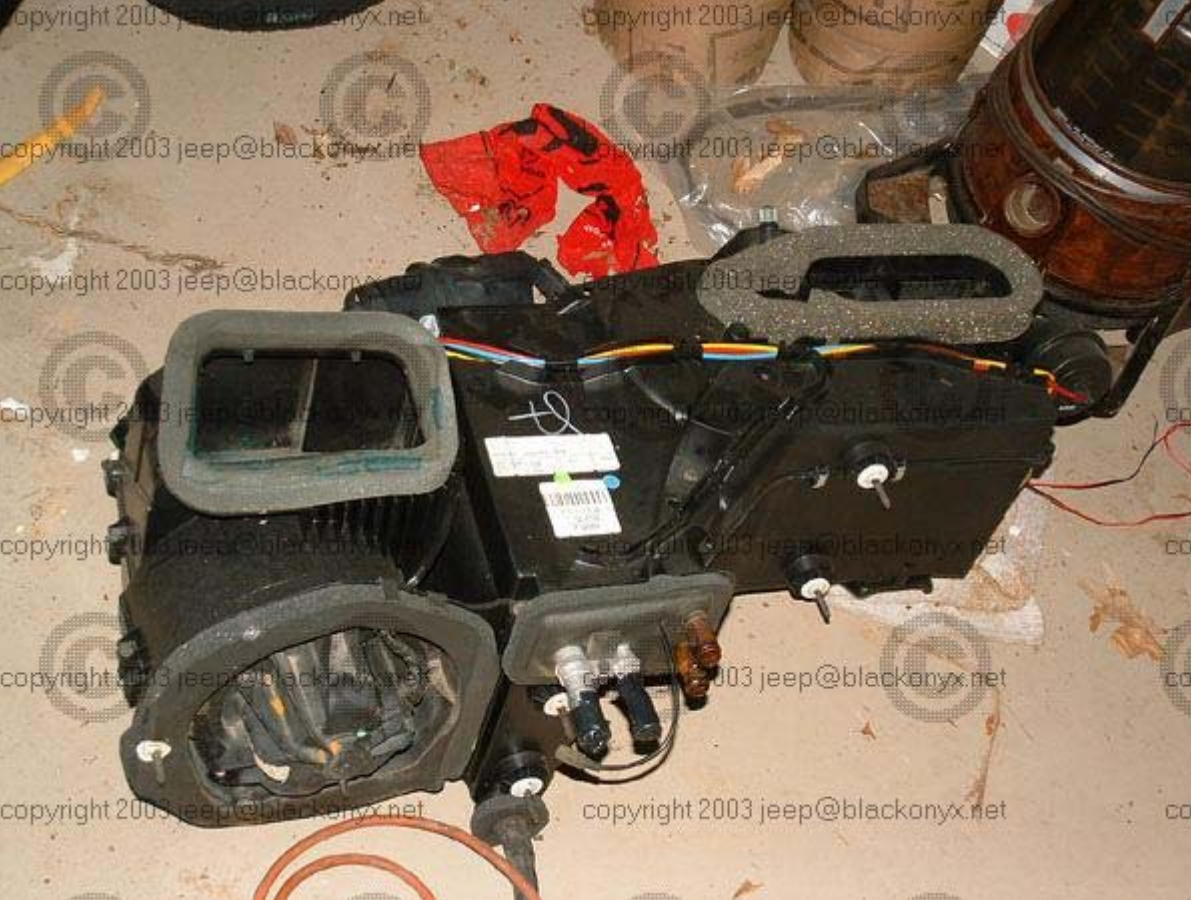
Heater box

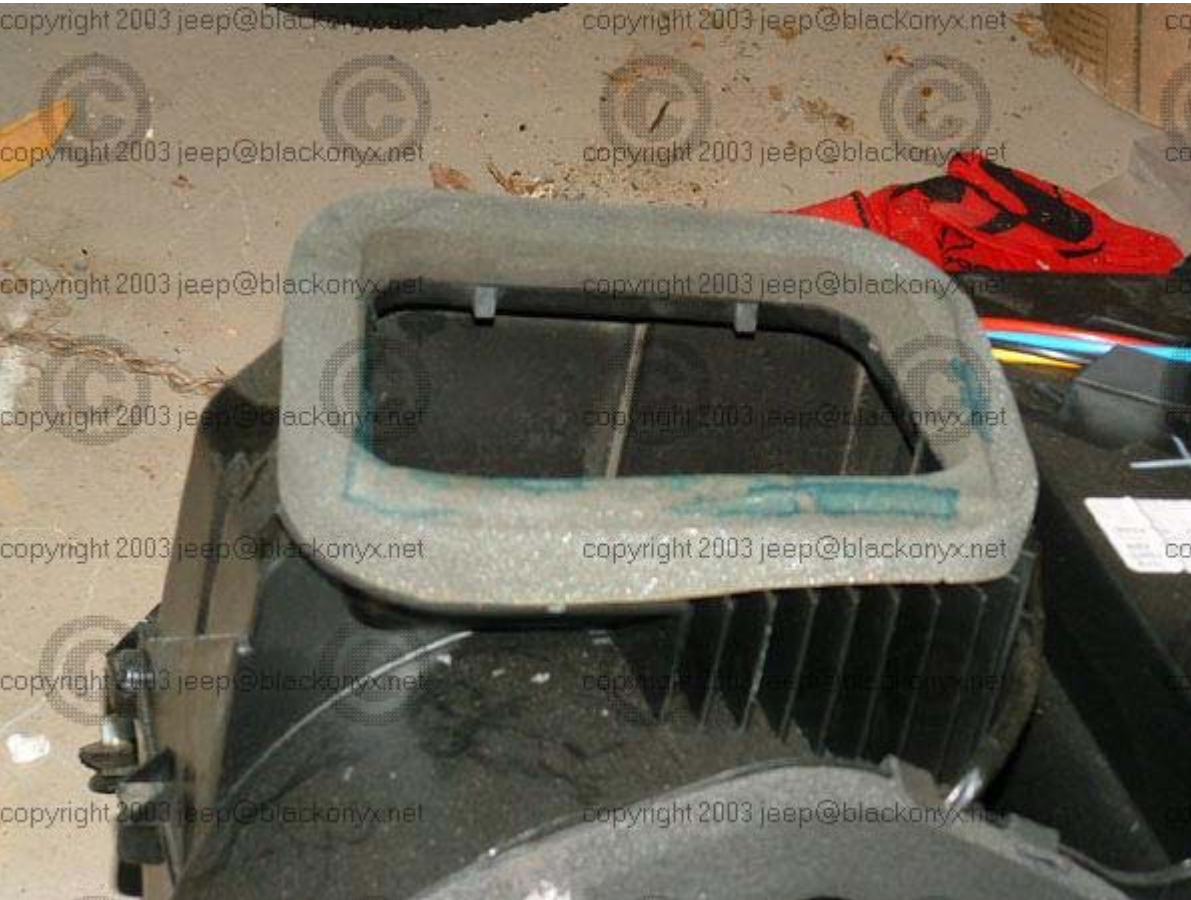
Foam blue from tracer ink

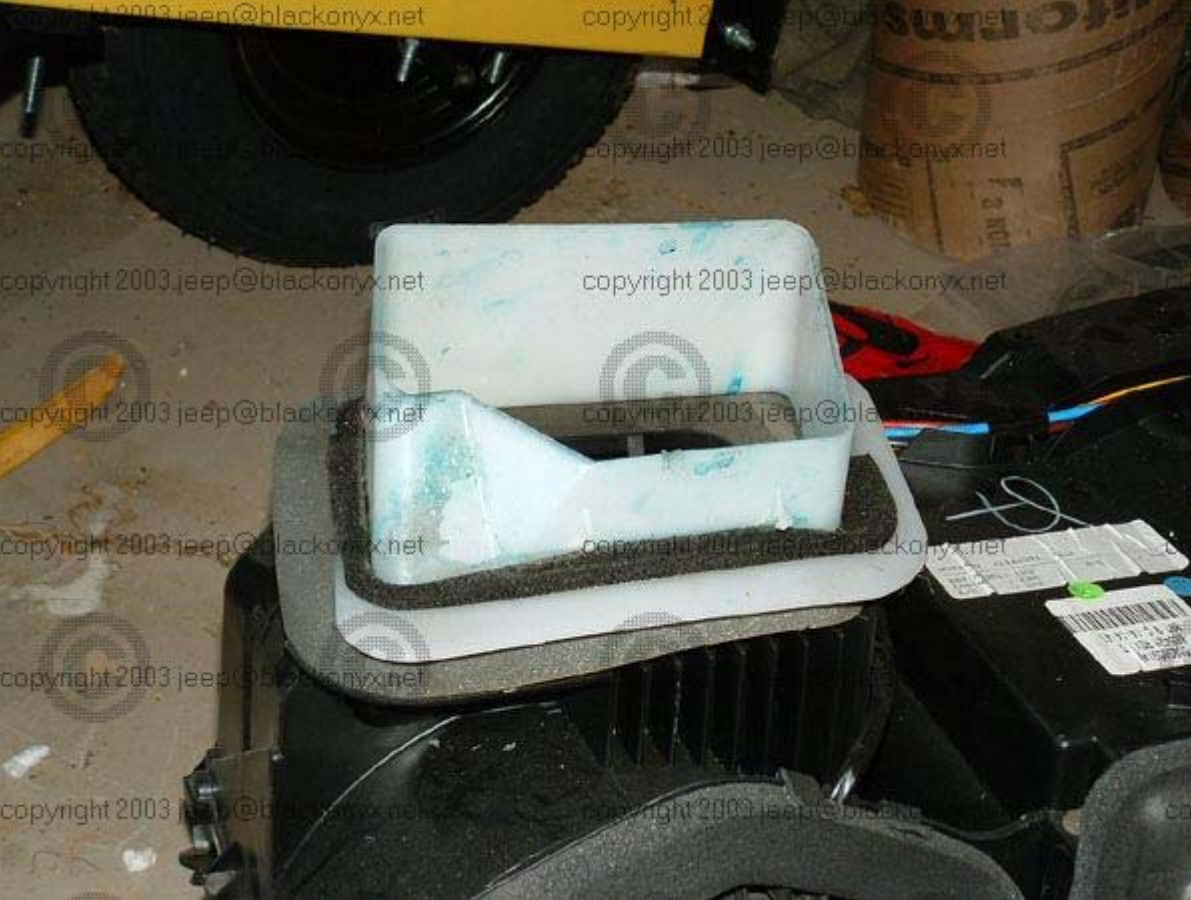
Position of offending seal

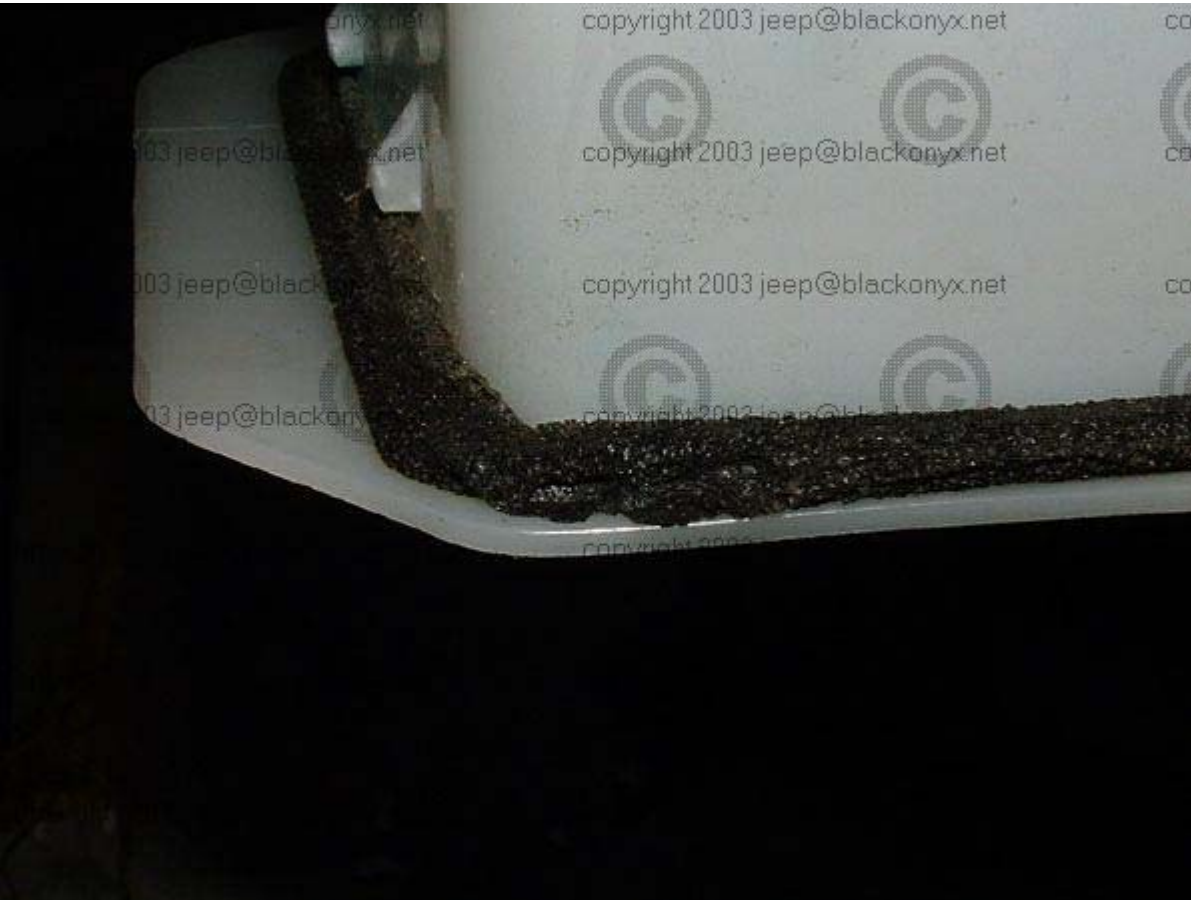
Offending seal -- just foam -- this was suppose to last several years??

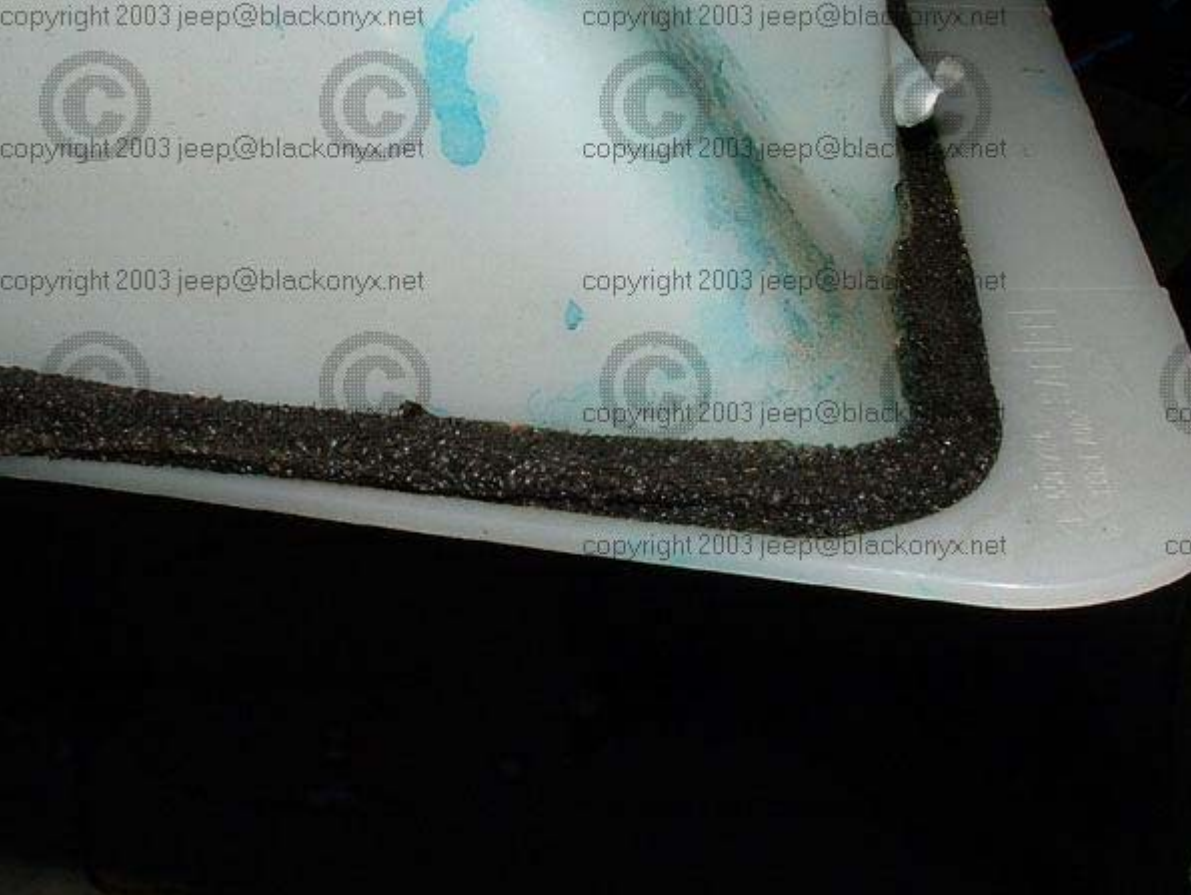
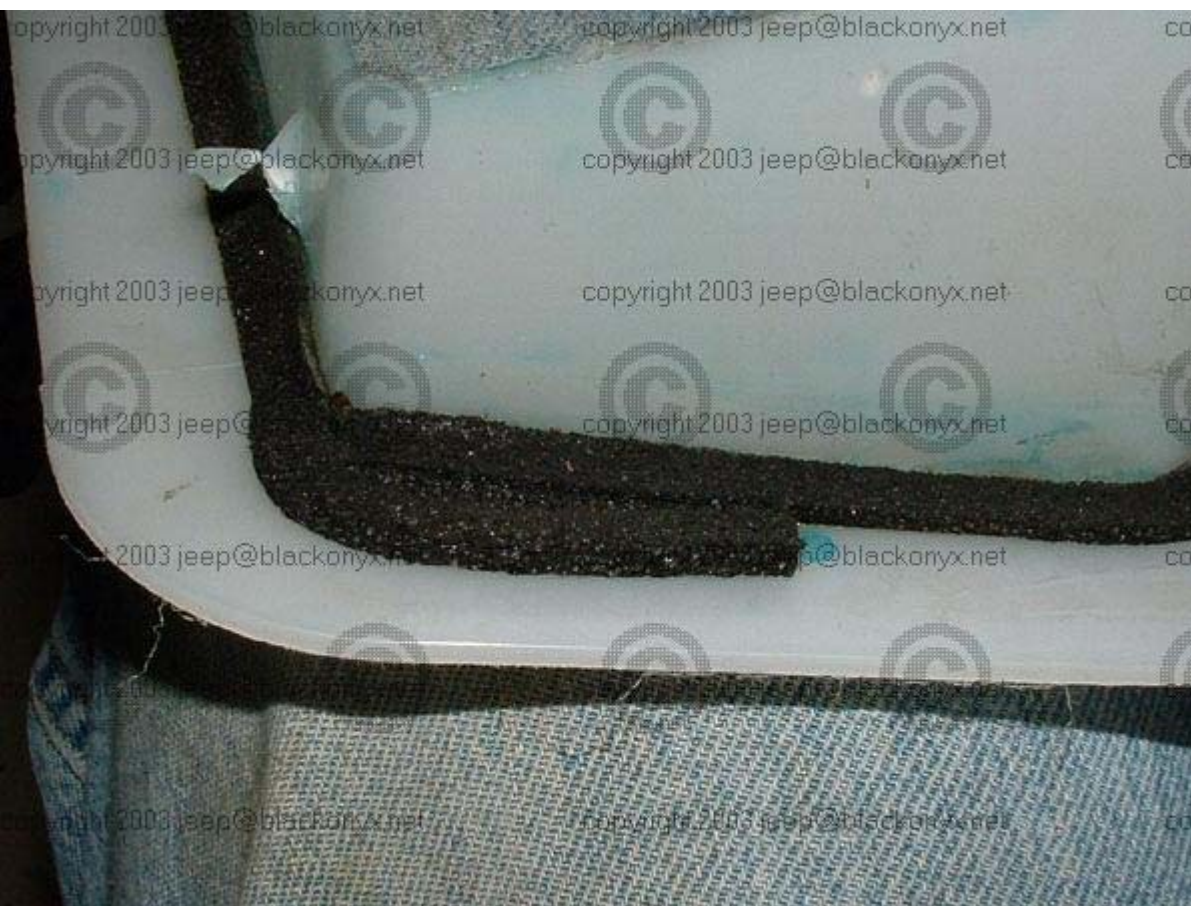
I like how they sloppily put the foam on

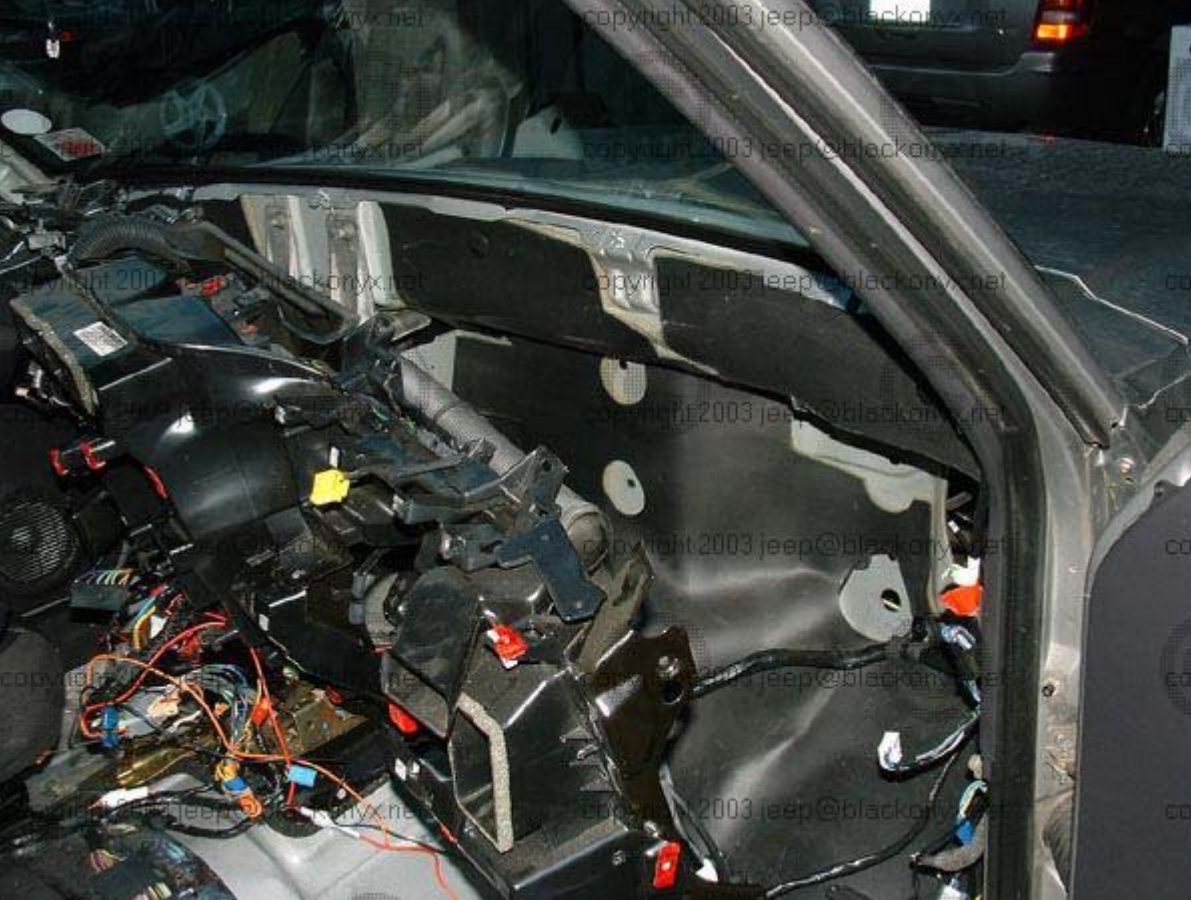
Empty dash

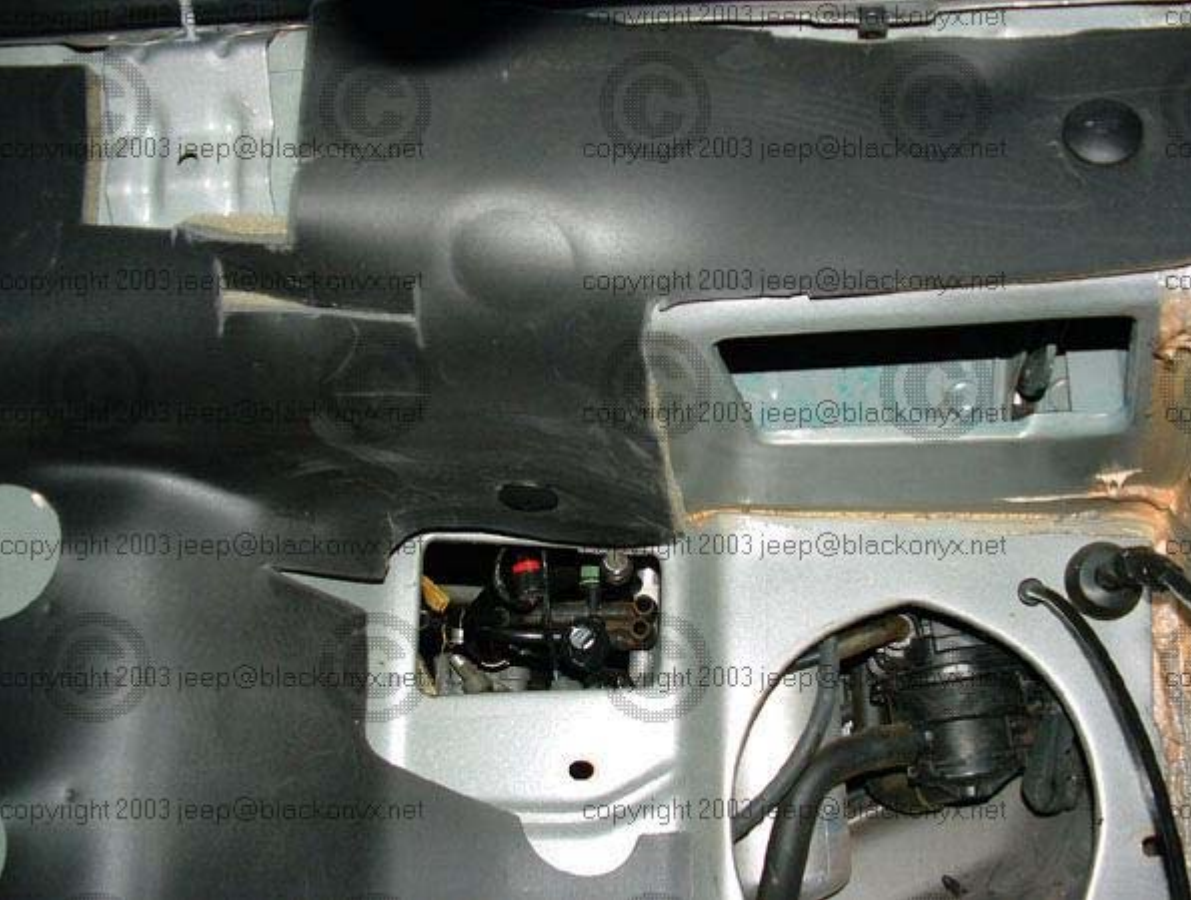
Upper hole is into cowl; lower two into engine bay
