Axle half shaft U-joint replacement

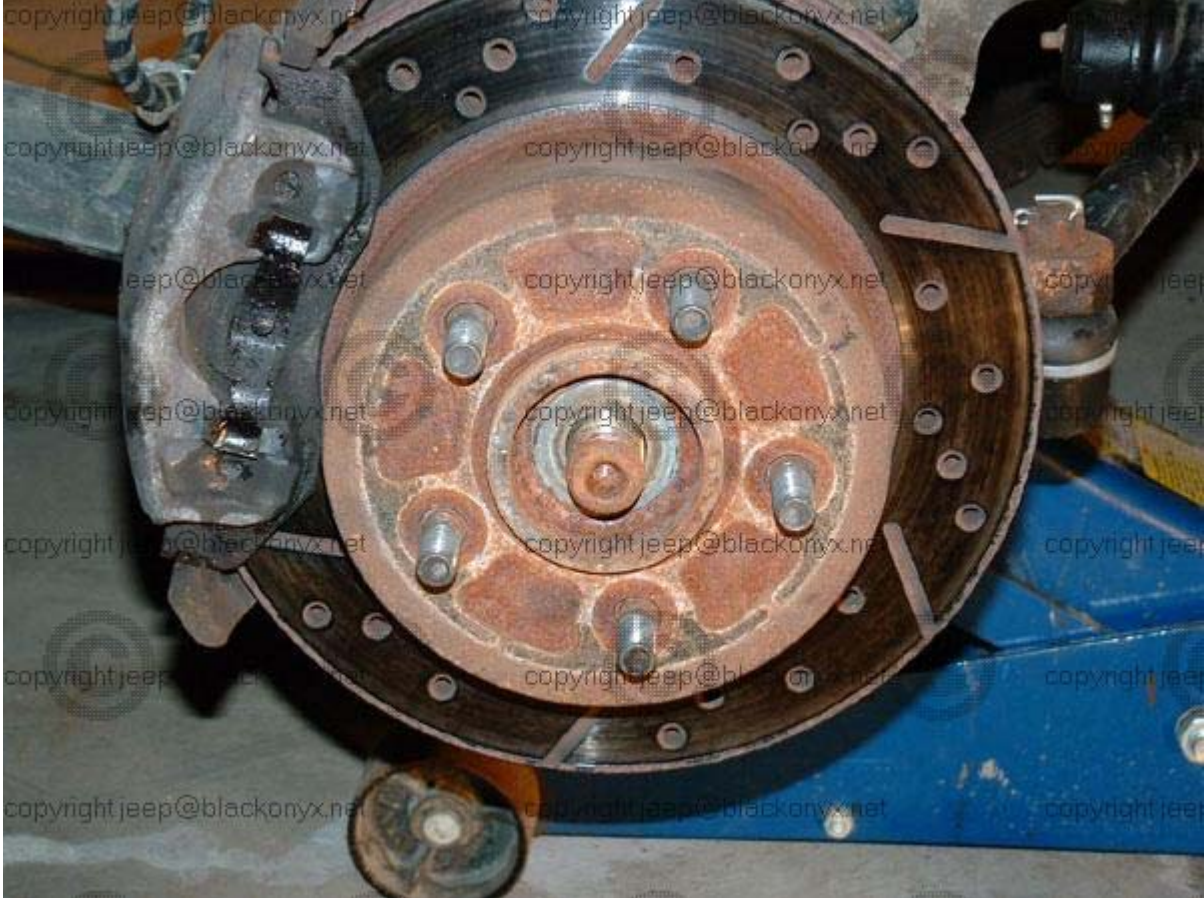
First remove the wheel. Then the cotter pin, hub nut retainer and anti rattle washer. Now you will have clean access to the hub bolt. Leave the brake caliper on for now, as it will hold the rotor a bit and plus you may have to put the tire back on. The hub nut can now be removed. It was really easy on my 2000 XJ... a few seconds with the impact wrench and it was off. I was expecting a bit more effort than this. If it doesn't come off with an impact wrench you will need to use a large breaker bar. Either have someone step on the brake pedal while you operate the breaker bar or put the tire back on, put it on the ground and use the socket through the hub hole in the wheel. Also, PB blaster will help here, but I didn't want to use it with the brake hardware still on. At this point it should look like this:

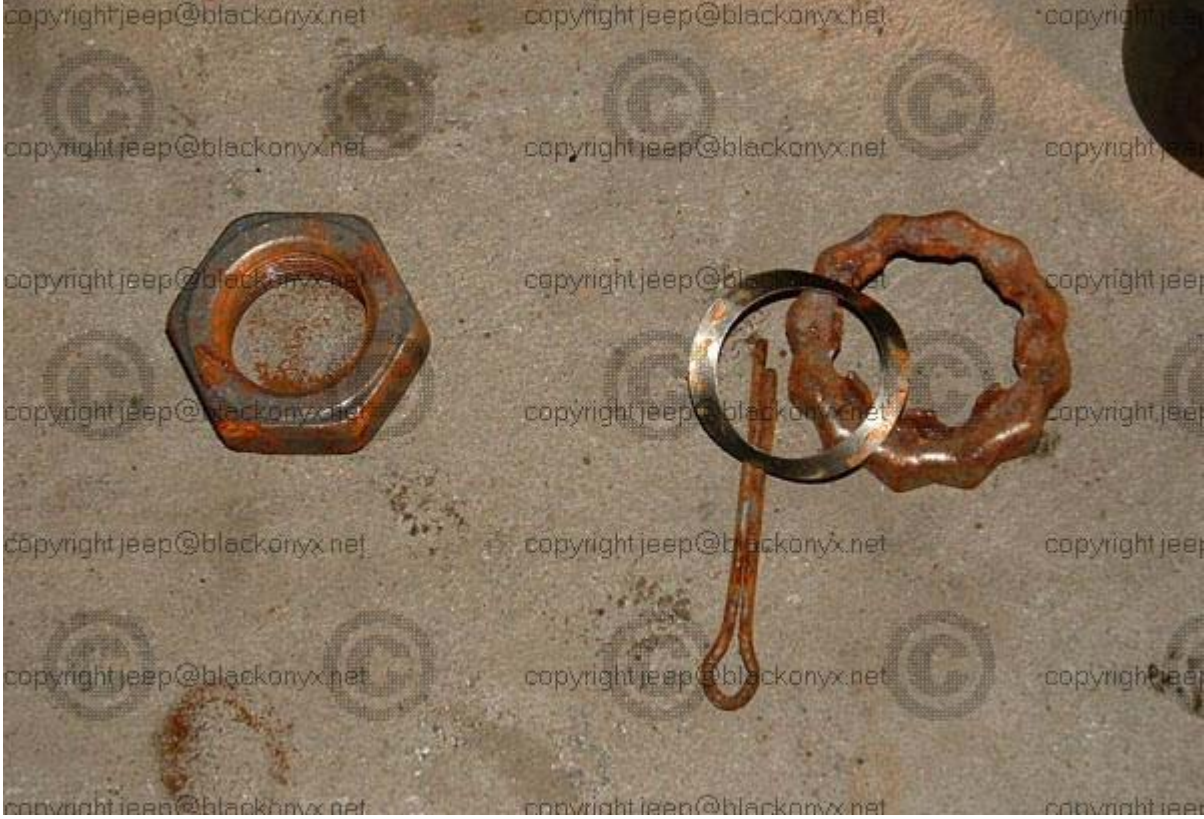
Hub nut, nut retainer, cotter pin and anti rattle washer:

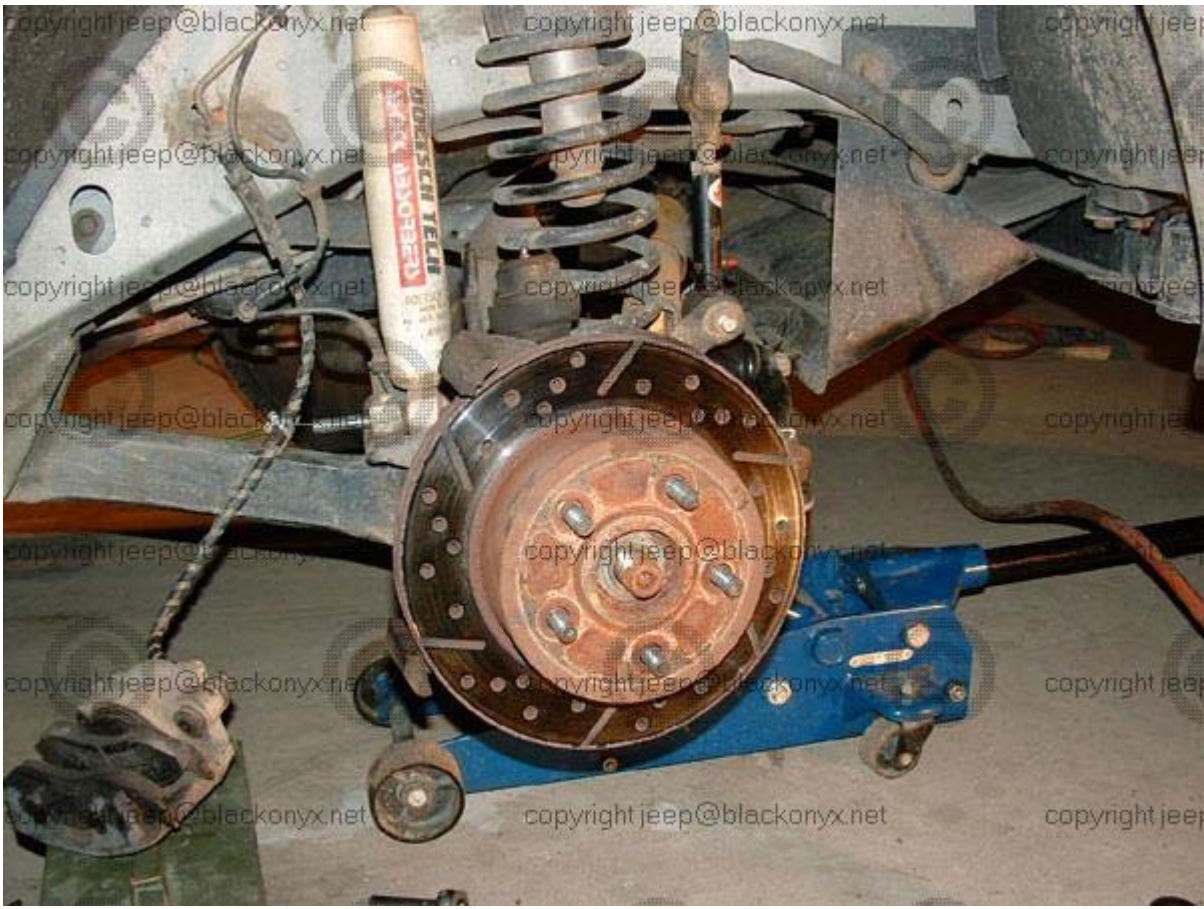
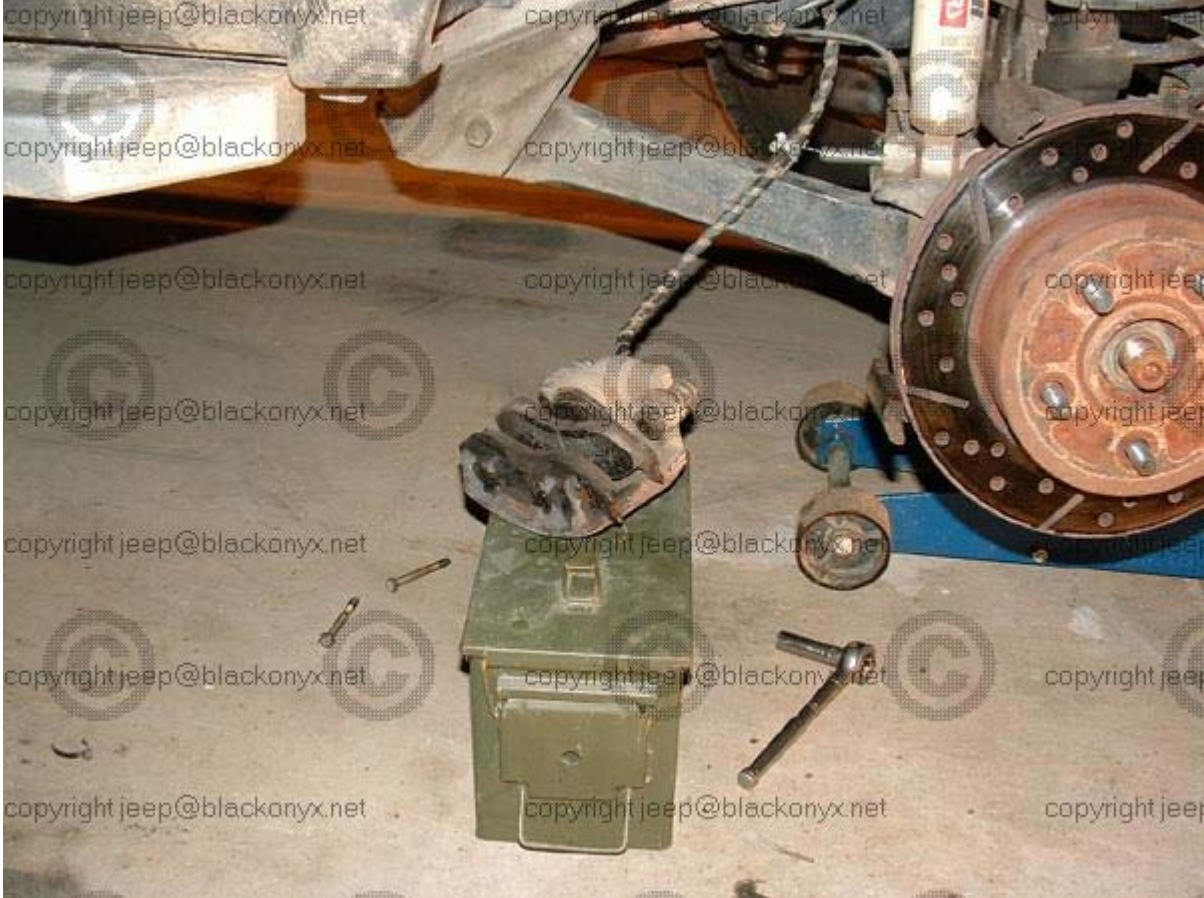
After the hub nut is off, you can remove the brake caliper secured by the two bolts. They are located on the back of the caliper. It is best to put the caliper on a raised surface to prevent the brake hose stretching.

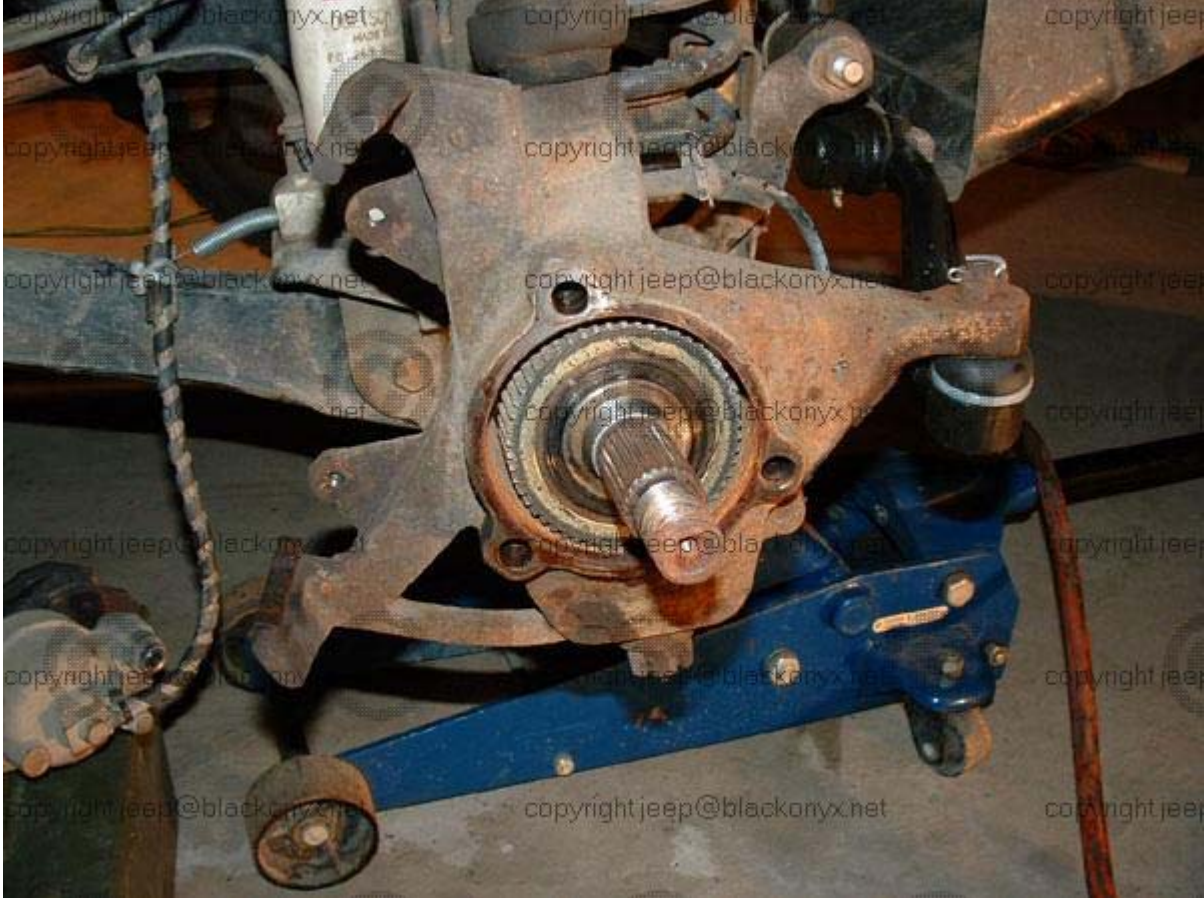
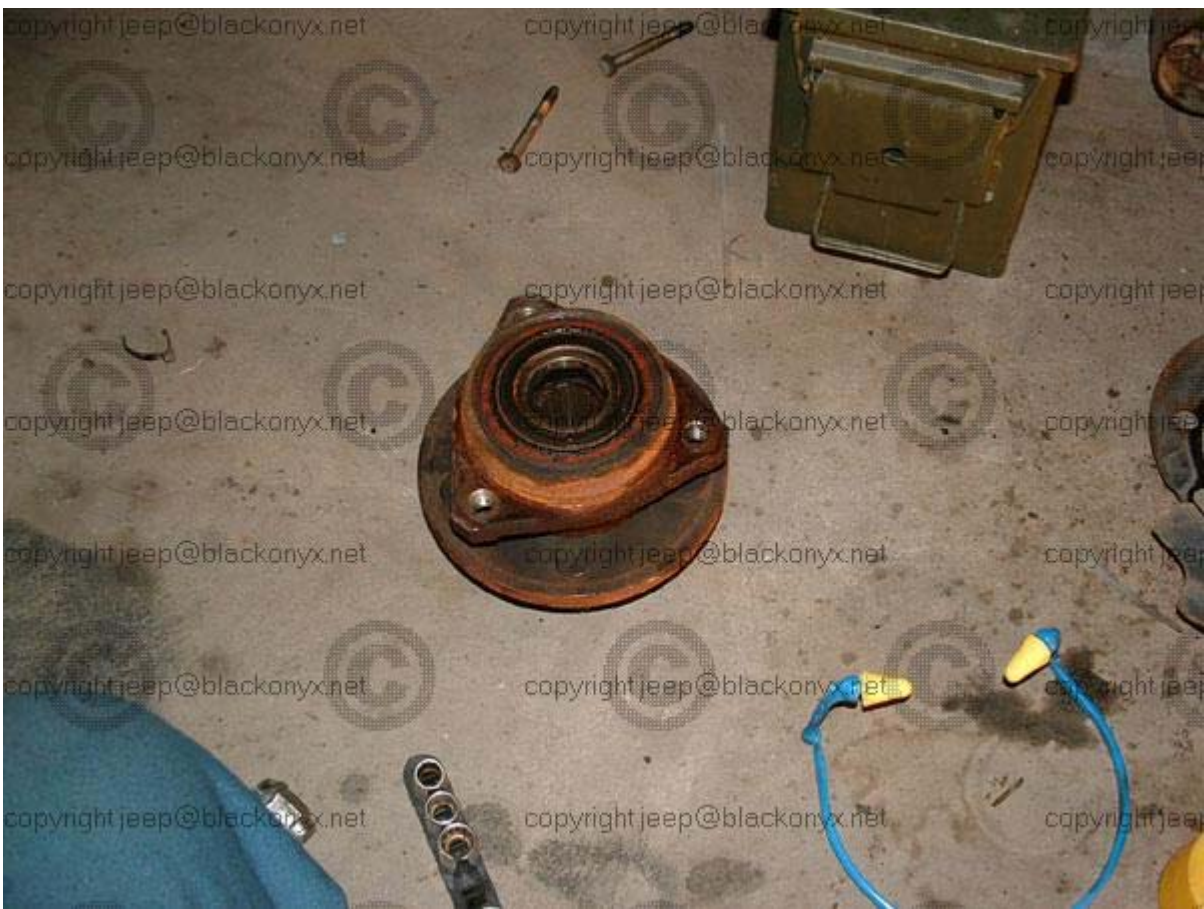
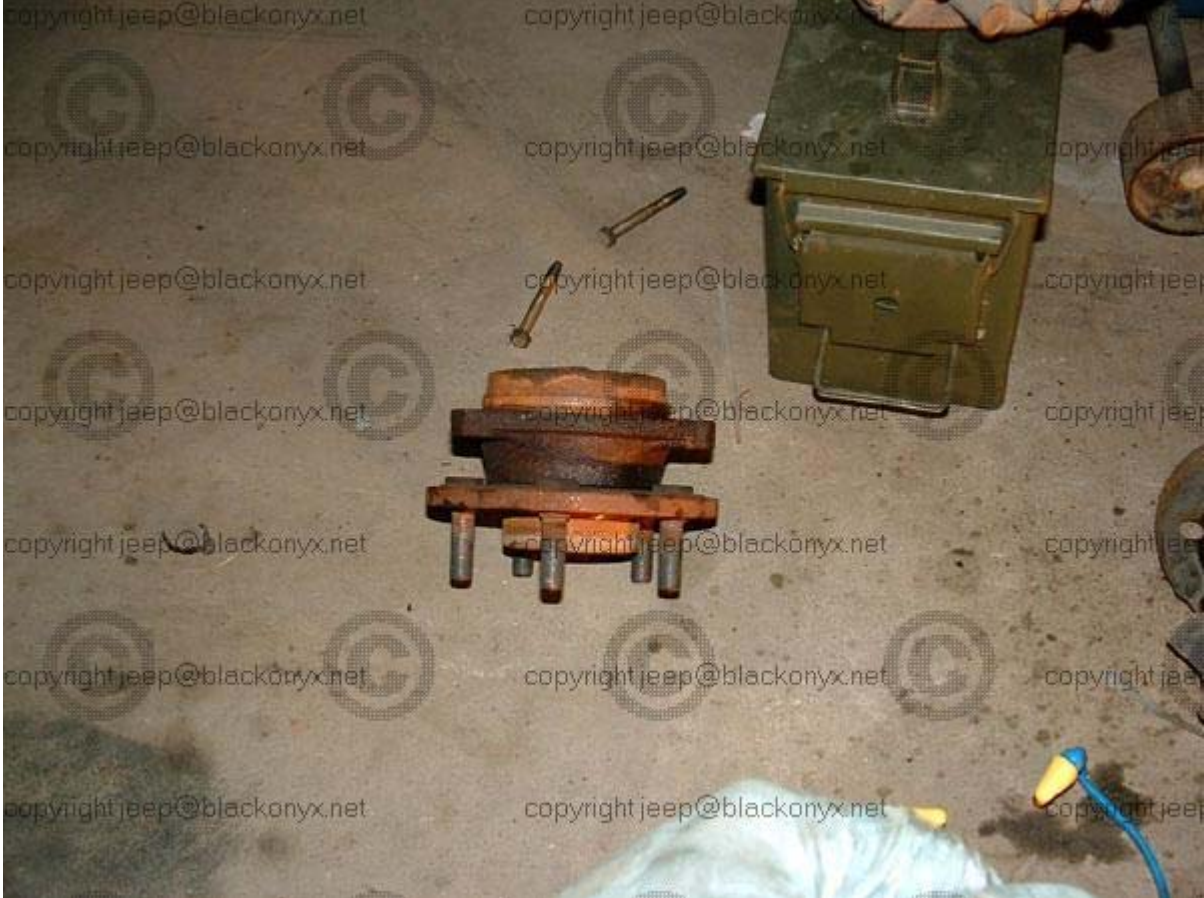
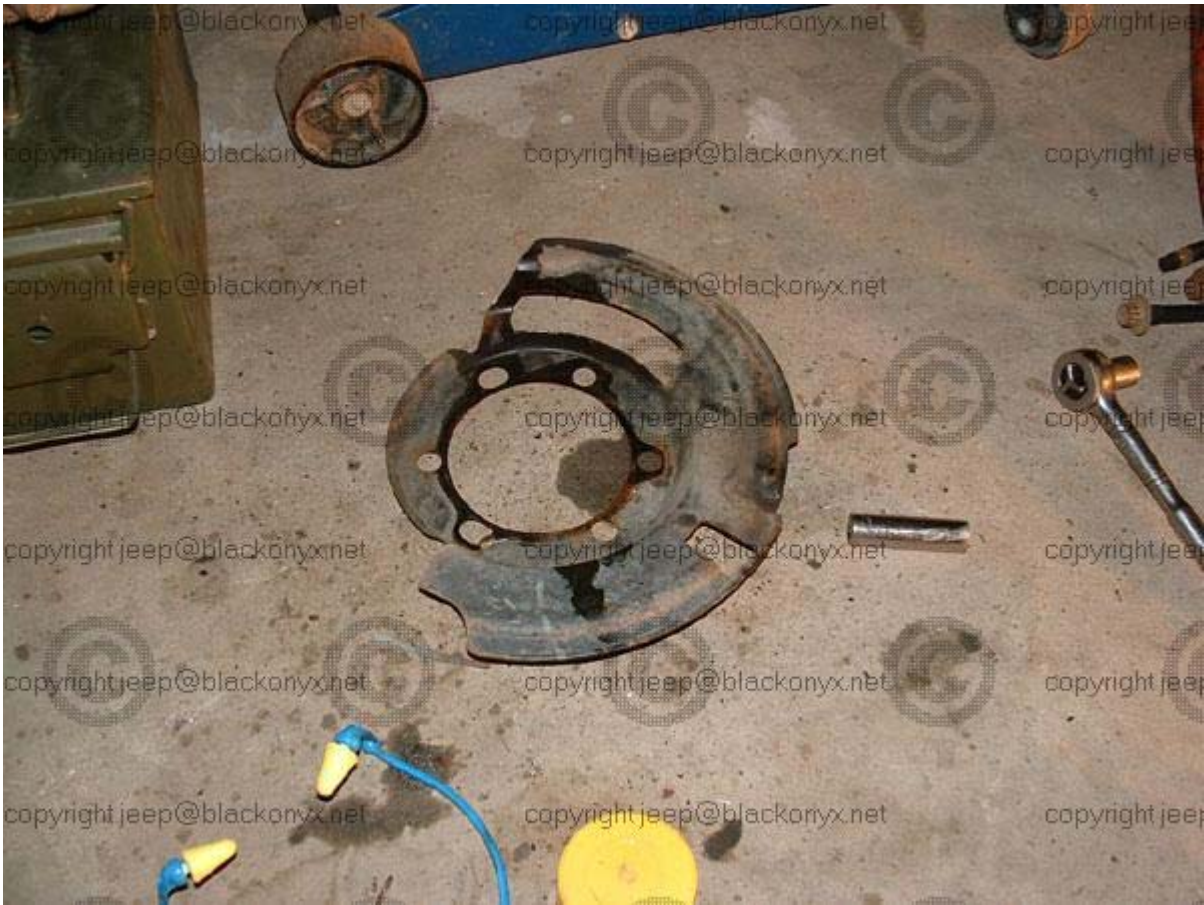
After I broke the bolts loose with the three foot breaker bar they were still too tight to remove with the ratchet. I then went down to a one foot breaker bar I have. I eventually got to the point to just use a ratchet to remove them. Once the bolts are out you have to remove the hub some way. I have heard of people using some sort of puller on them and separating the two halves of the bearing. This I didn't want to do, as I believe the hub is still good. I used a air chisel to free the hub from the steering knuckle. In the process I did a bit of damage to the brake rotor shield (not sure if I will reuse this part or not). Below is pics of the freed hub, rotor shield and the steering knuckle.

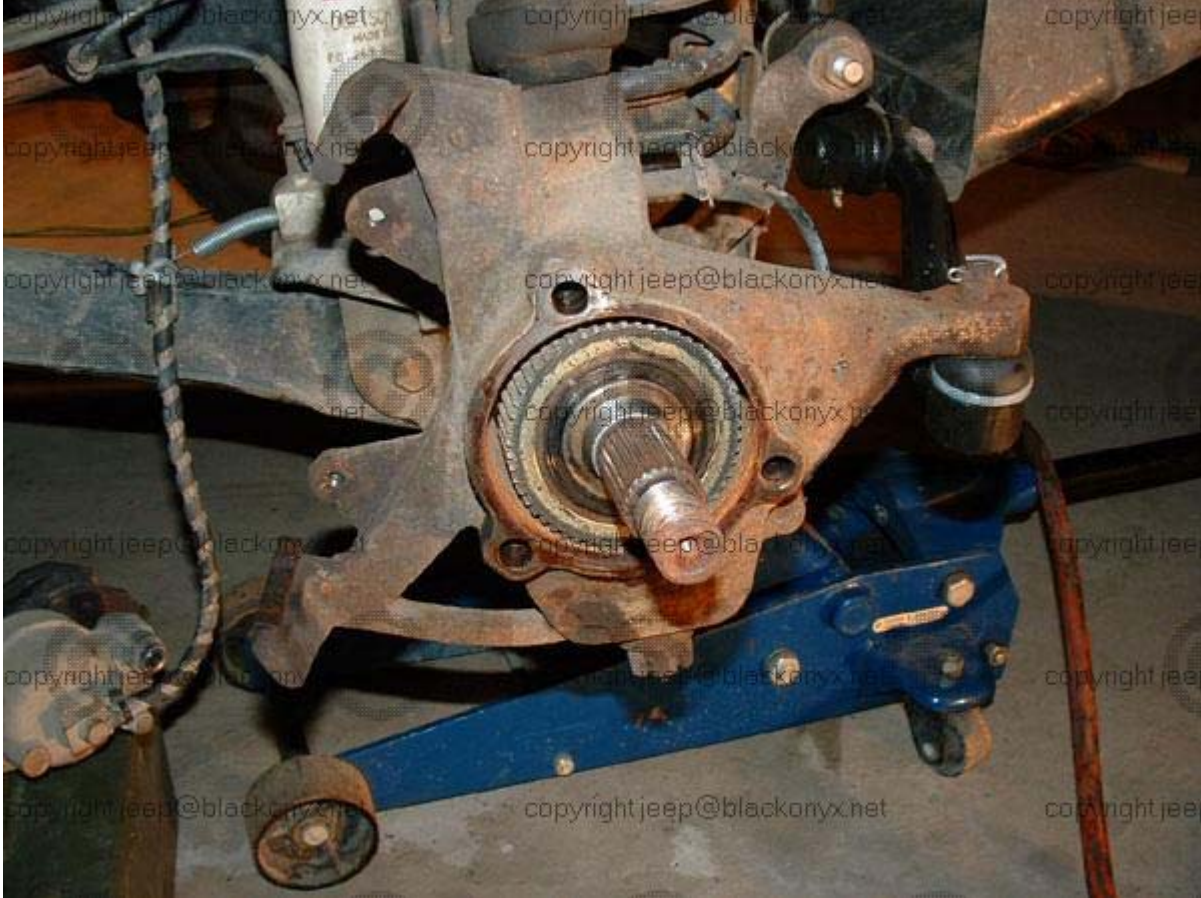
Now your view should look similar to this:

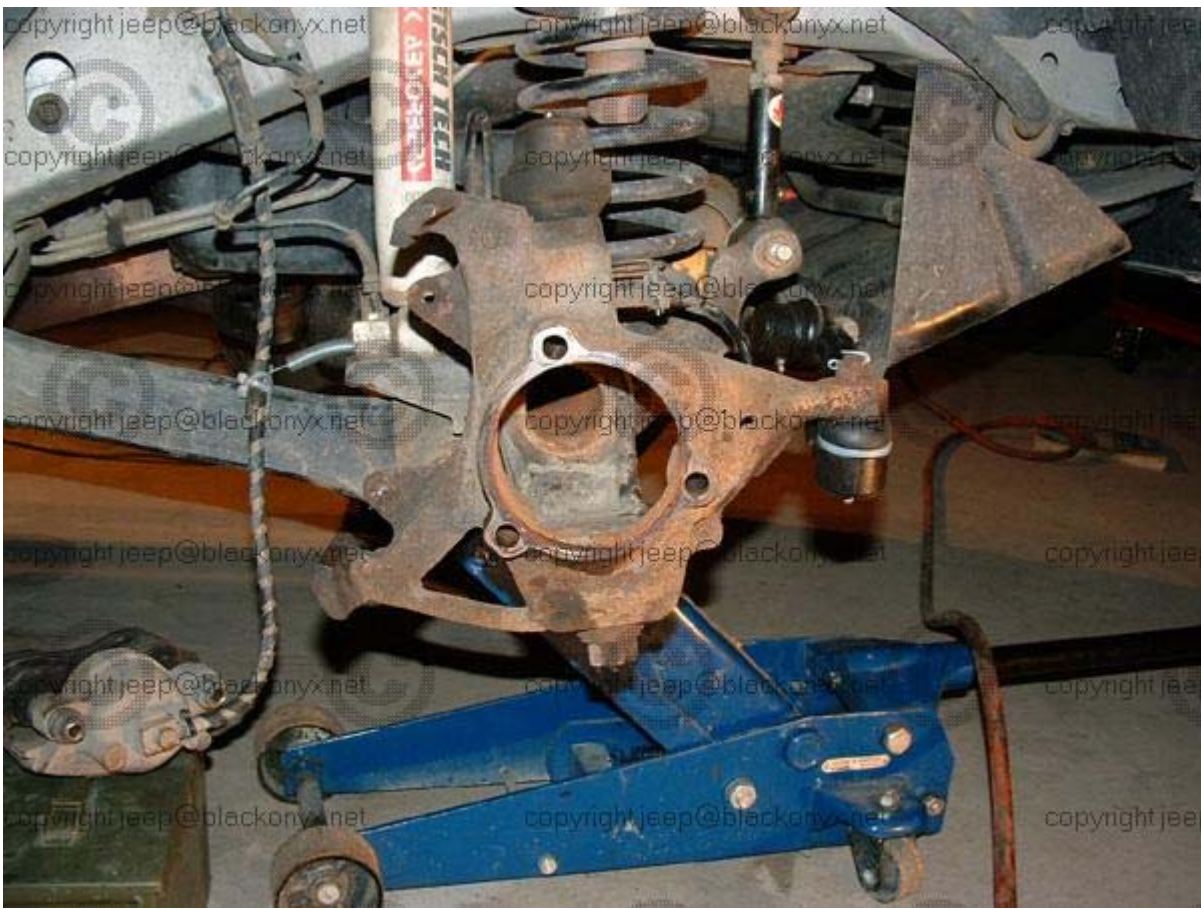
If you have ABS, remove the sensor. After that is done the axle half shaft should slide right out. Leaving this view of the knuckle:

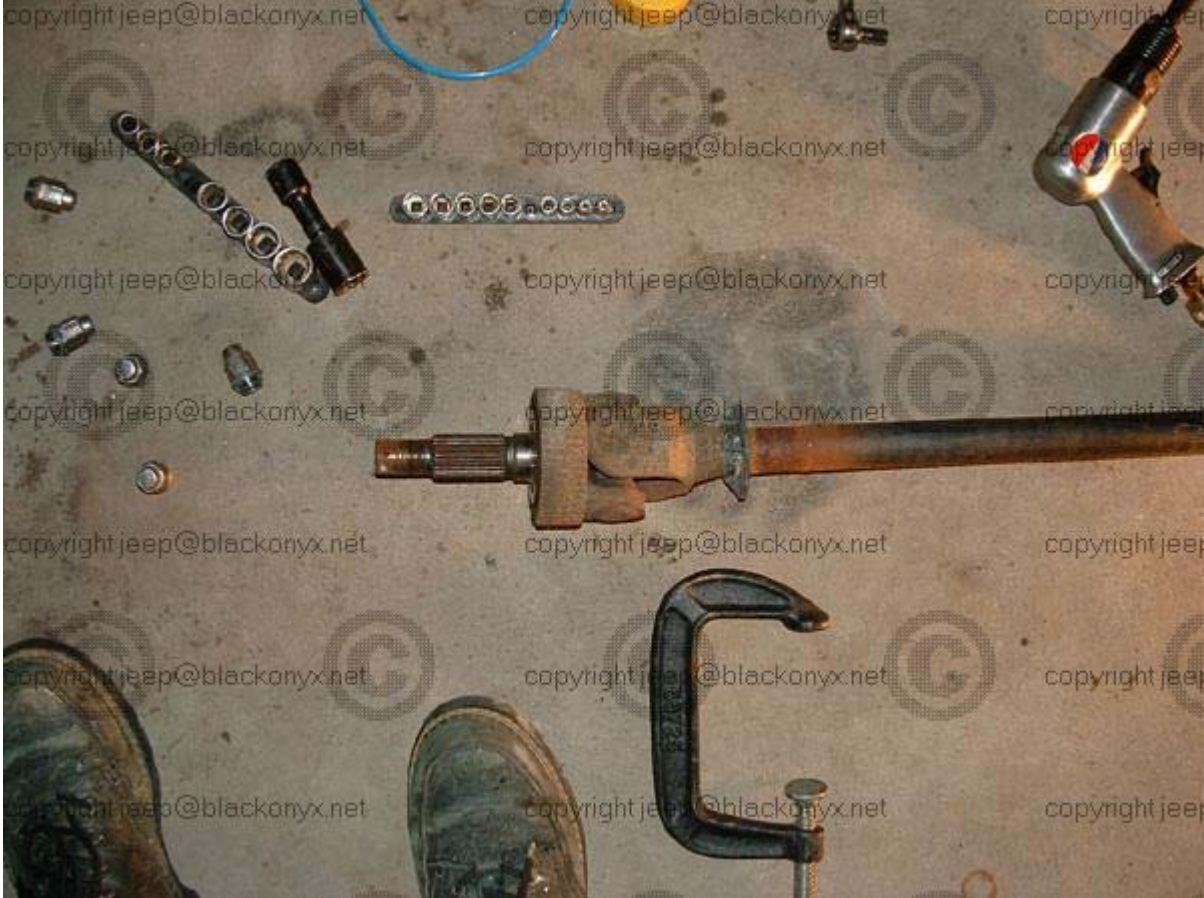
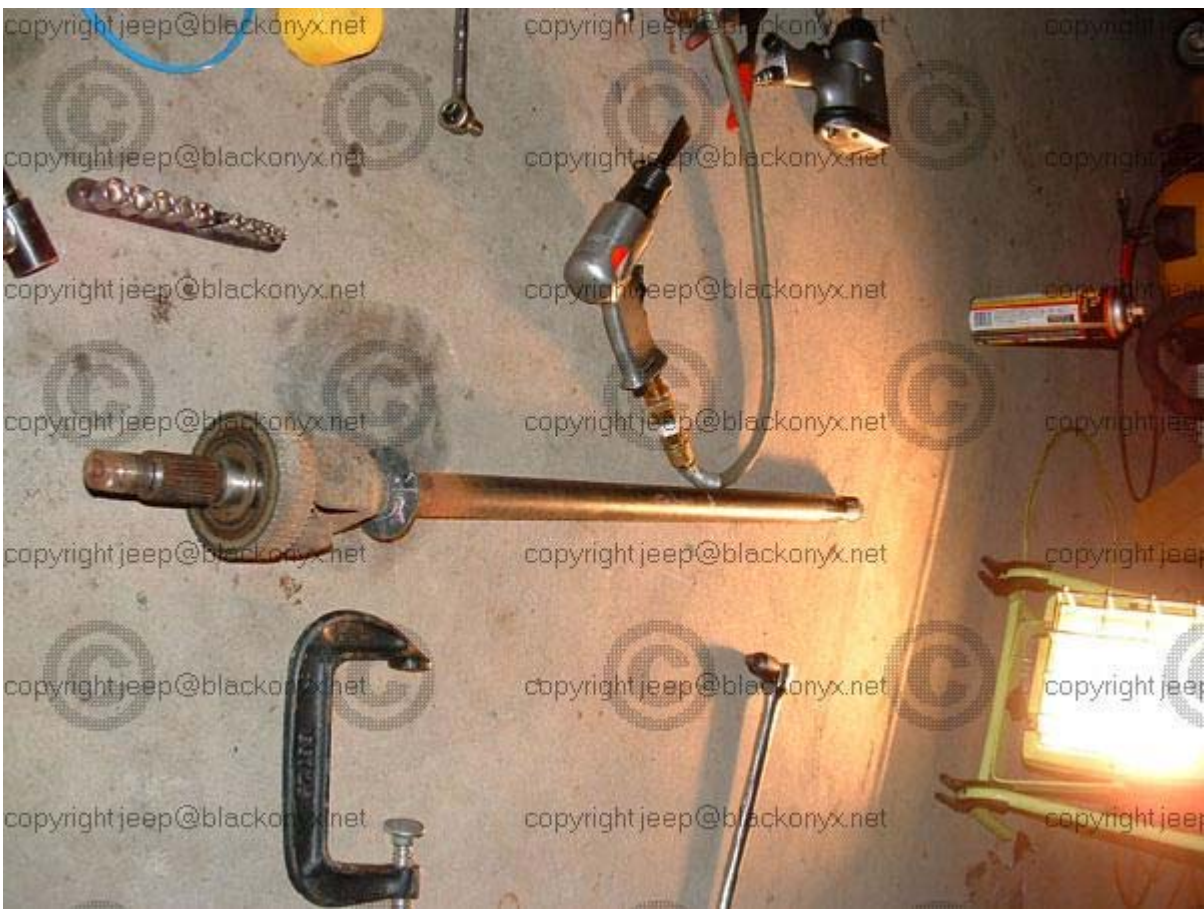
And the passenger side half shaft with the offending u-joint.

Upon inspection of the u-joint I found one axis fairly easy to move, but the other axis was pretty hard to move by hand. Yeah, this is what is causing part of the vibes, if not all.

Now comes the hard part: removing the u-joint. I managed to remove the c-clips, but getting the u-joint out was beyond me. My Bench clamp was too small and I bent a c-clamp in the process of trying to remove it. I will take this to a shop that has a bearing press to remove and install the new u-joint.

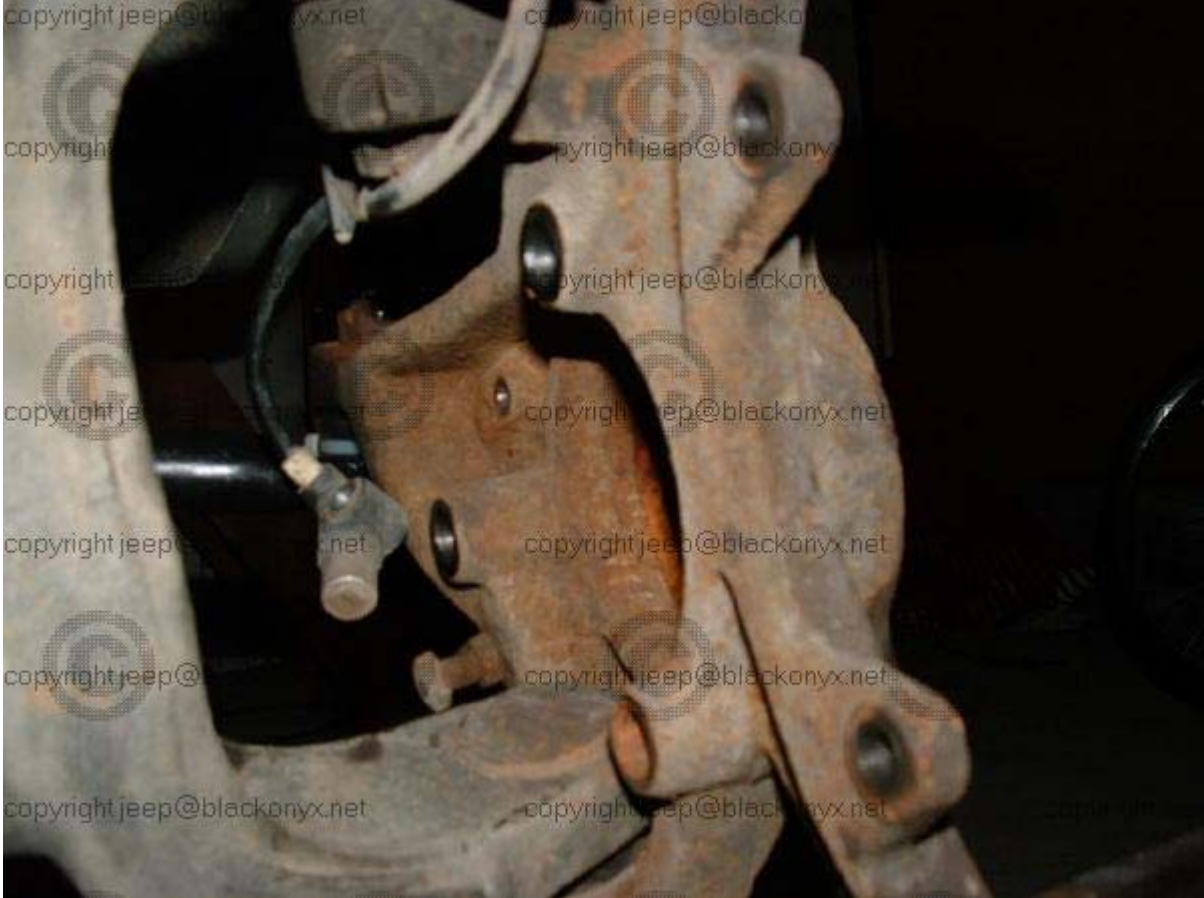
Here you see the holes through the knuckle to the hub:

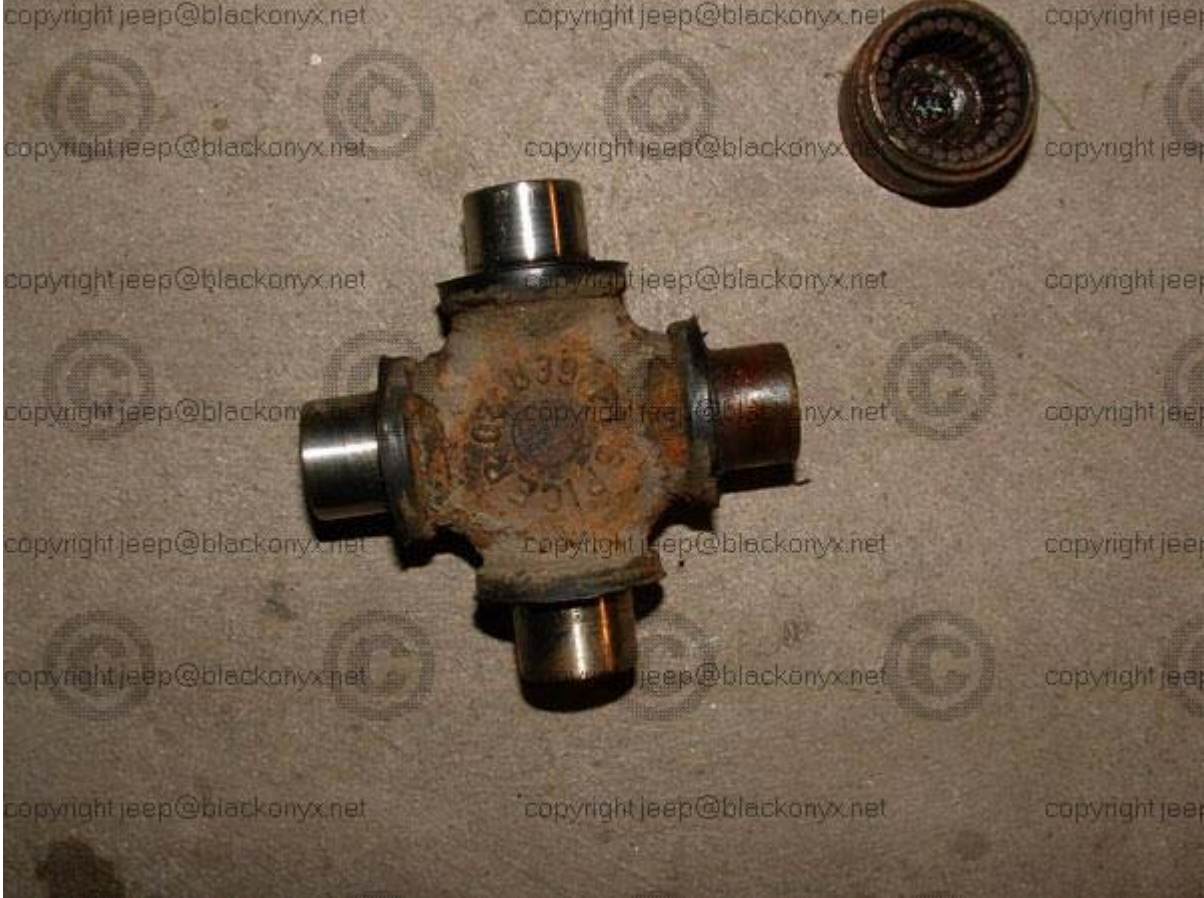
The "better" u-joint:

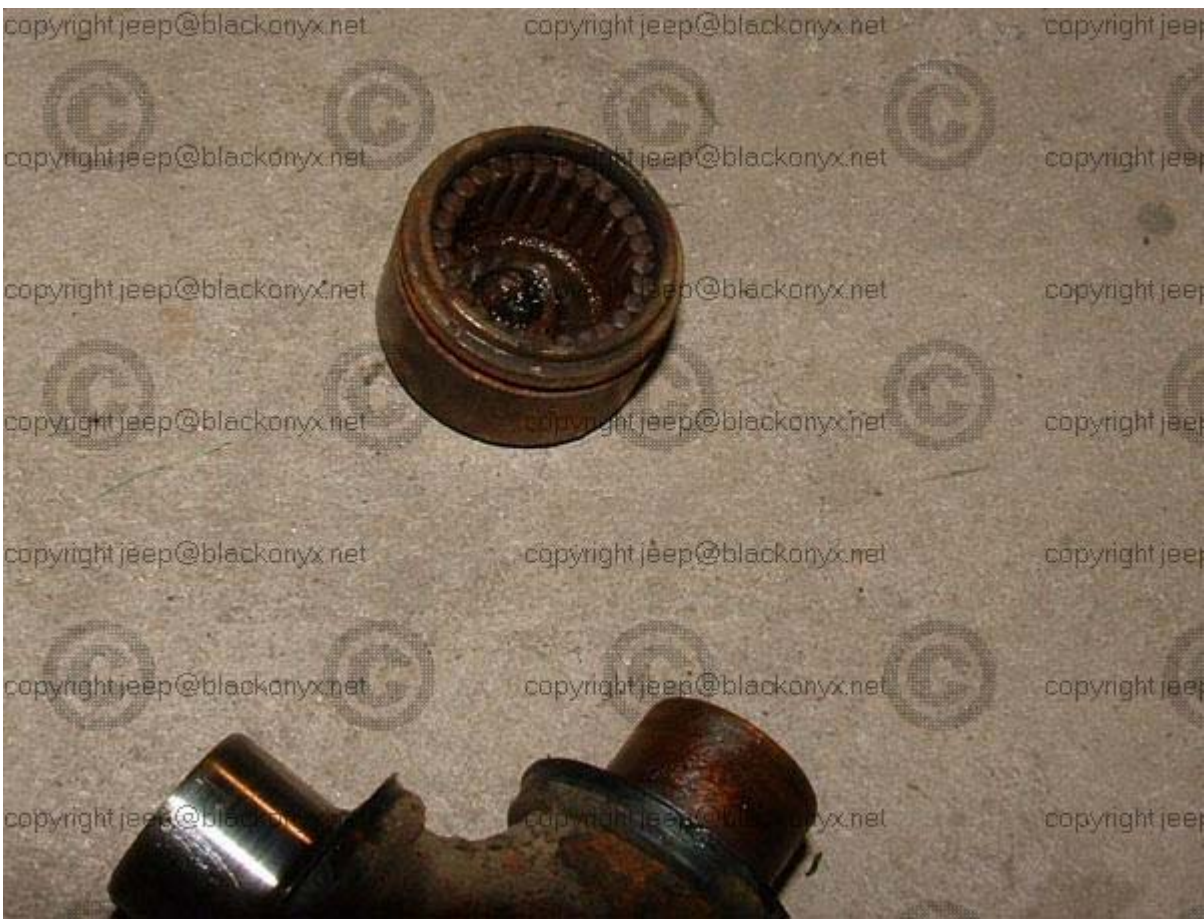
Mmm... lack of grease:

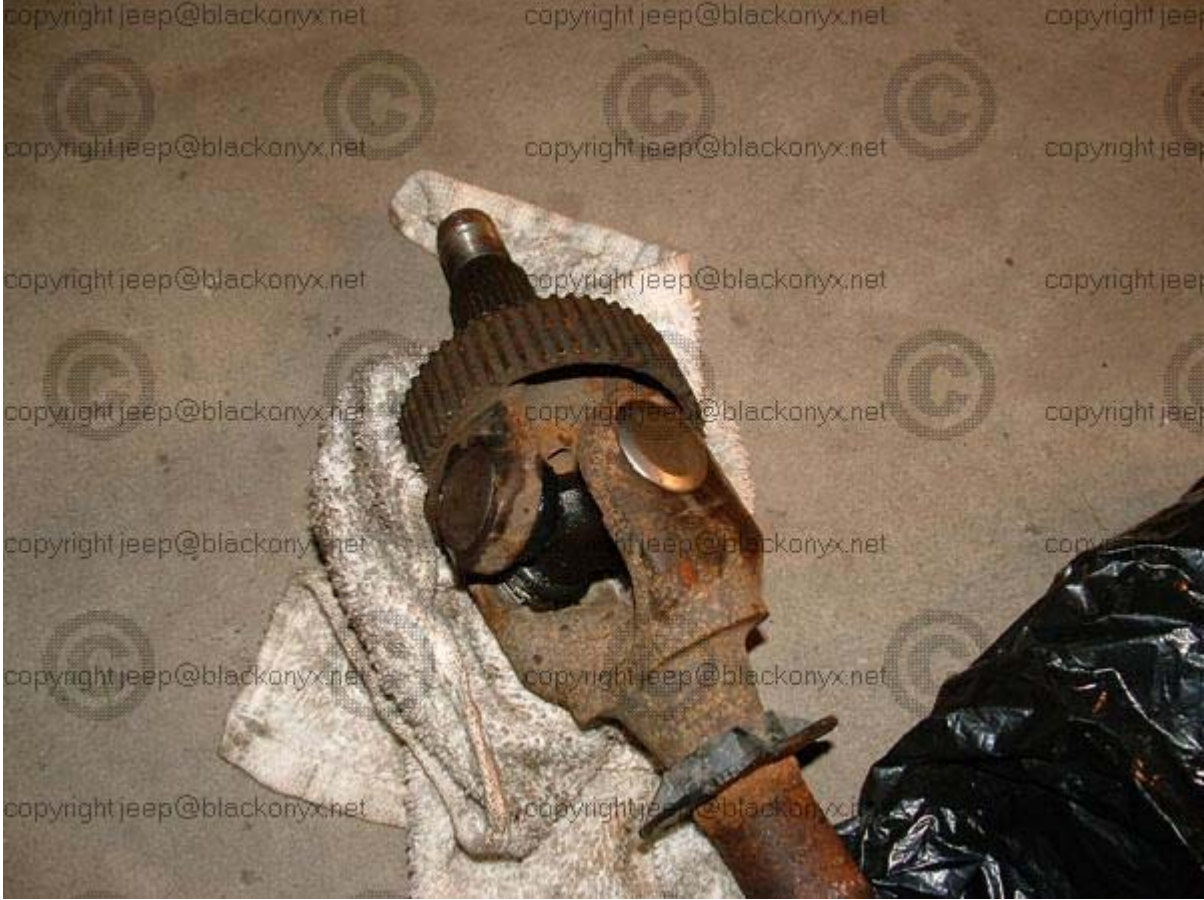
New u-joint installed:

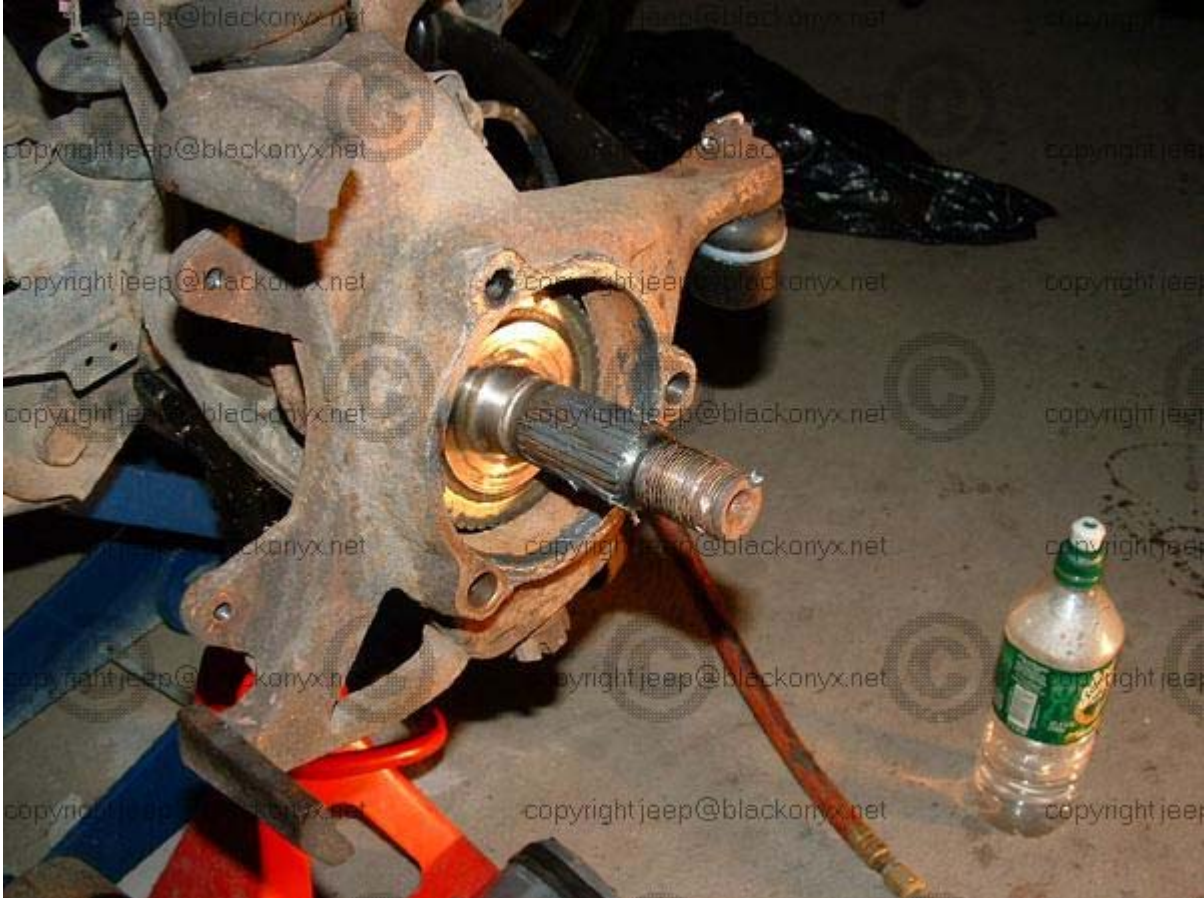
Mmmm... anti-seize:

Its just the reverse of installation. Use anti-seize where ever possible. I put it on all bolts, the hub's mating surface, and the half-shaft splines. In case I have to tae it apart it will be easier. Use proper torque values too. Below, I have listed some torque values, all in foot-pounds.

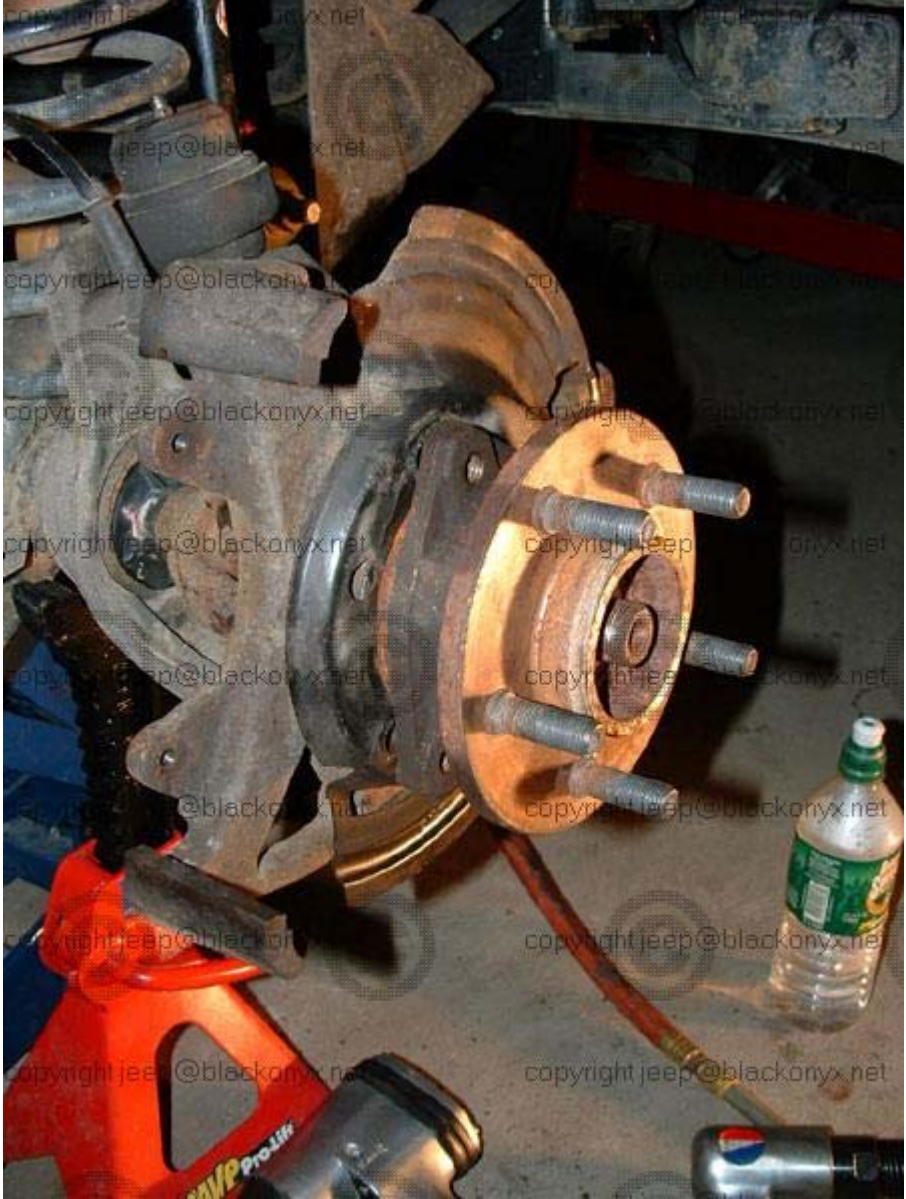
Hub being mounted:

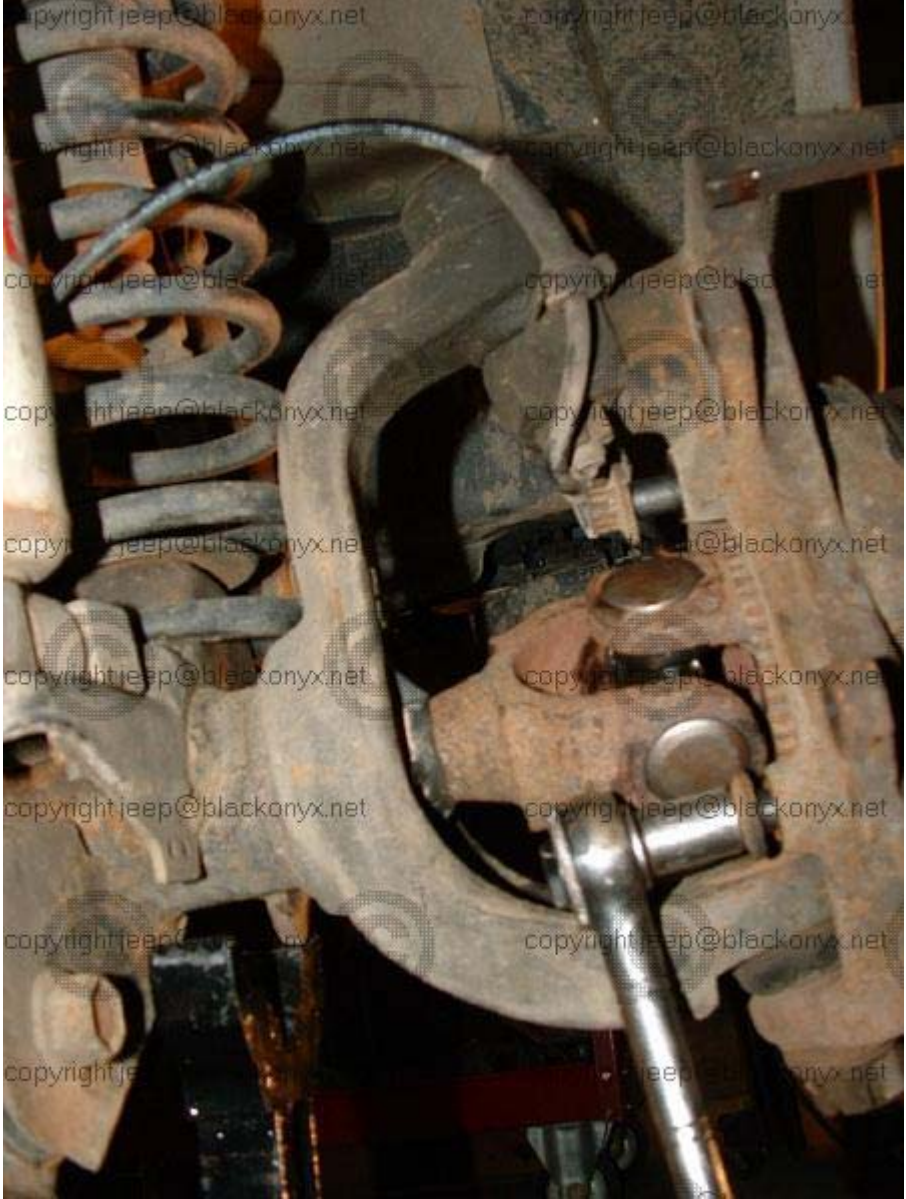
Bolts being inserted into steering knuckle and hub:

Hub assembly to steering knuckle bolts: 75

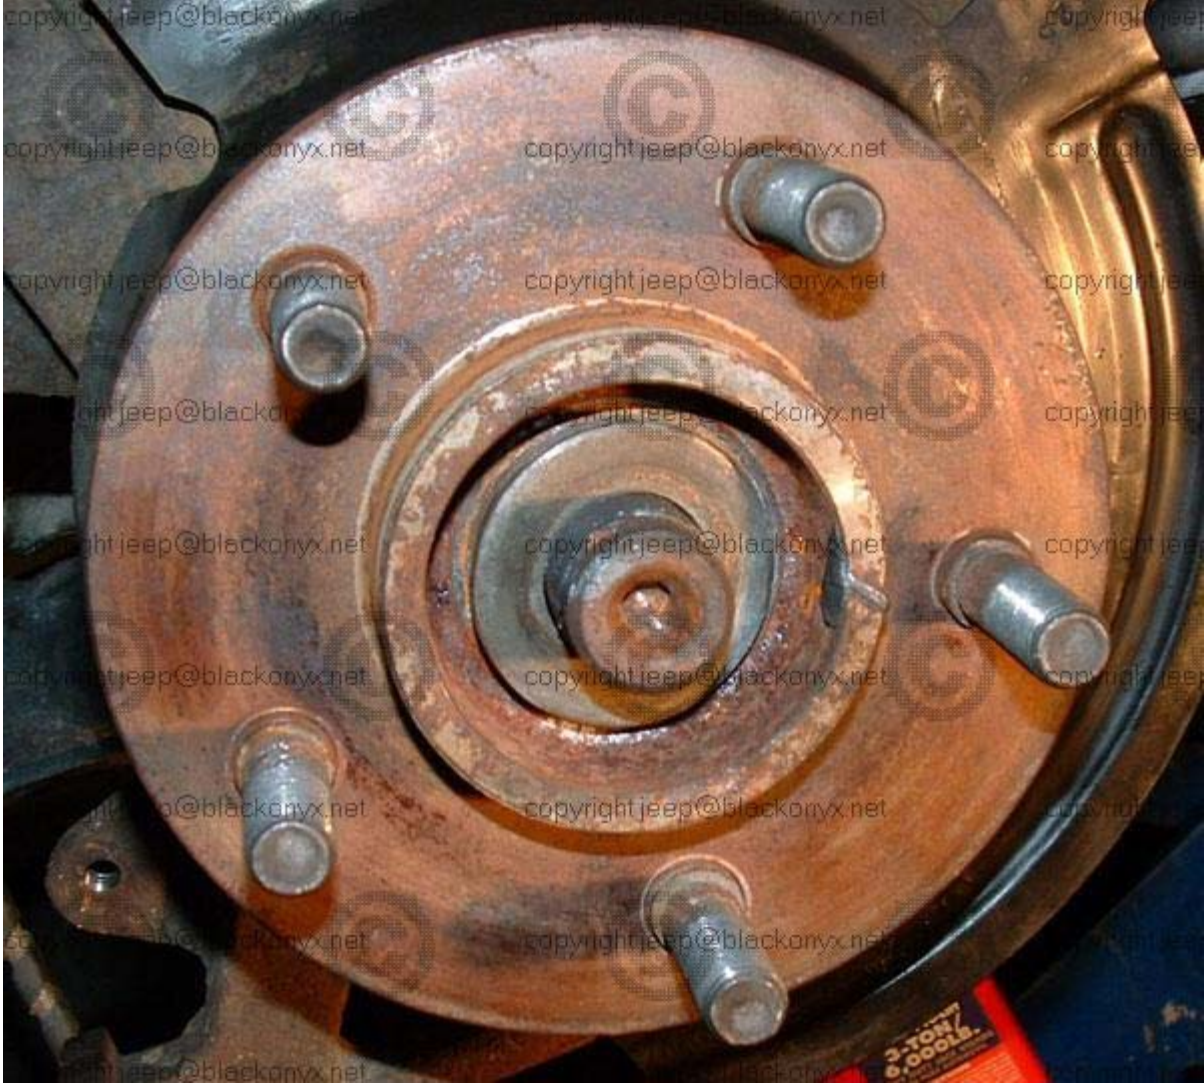
Washer first:
