Axle half shaft U-joint replacement

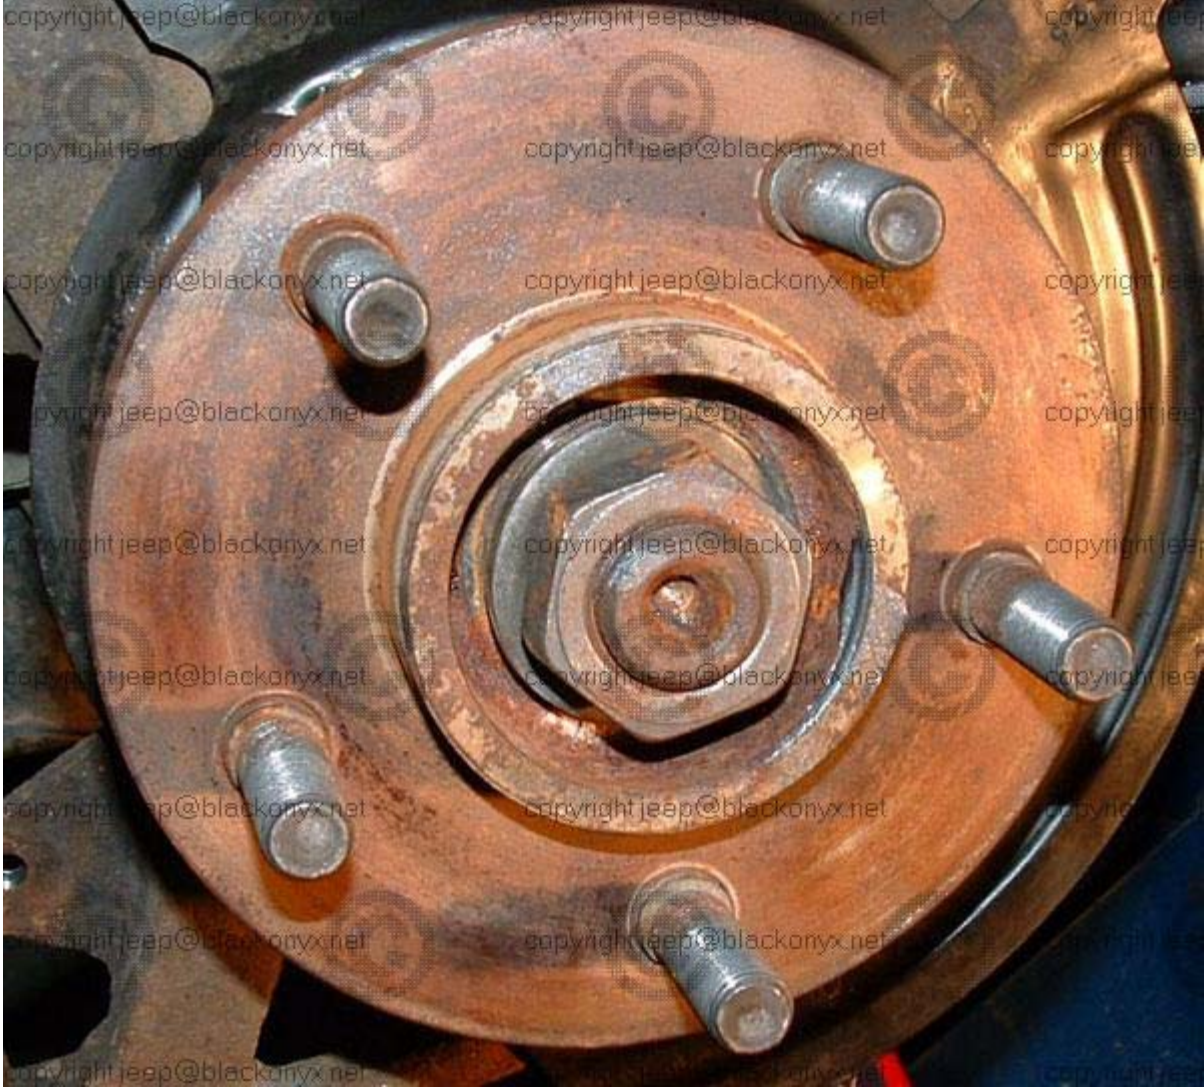
Than nut:

Axle hub nut: 175

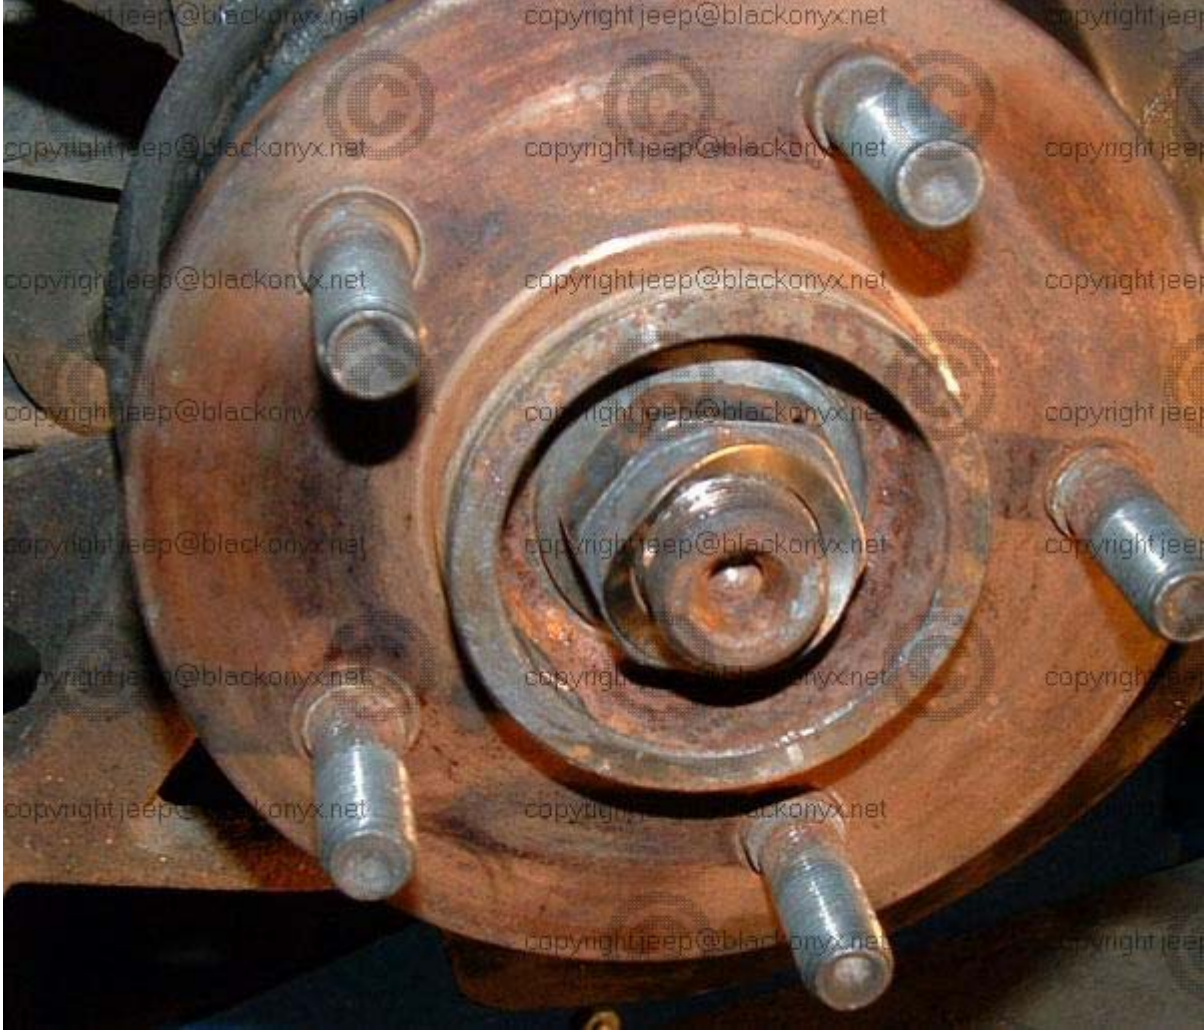
Than anti-rattle spring/washer:

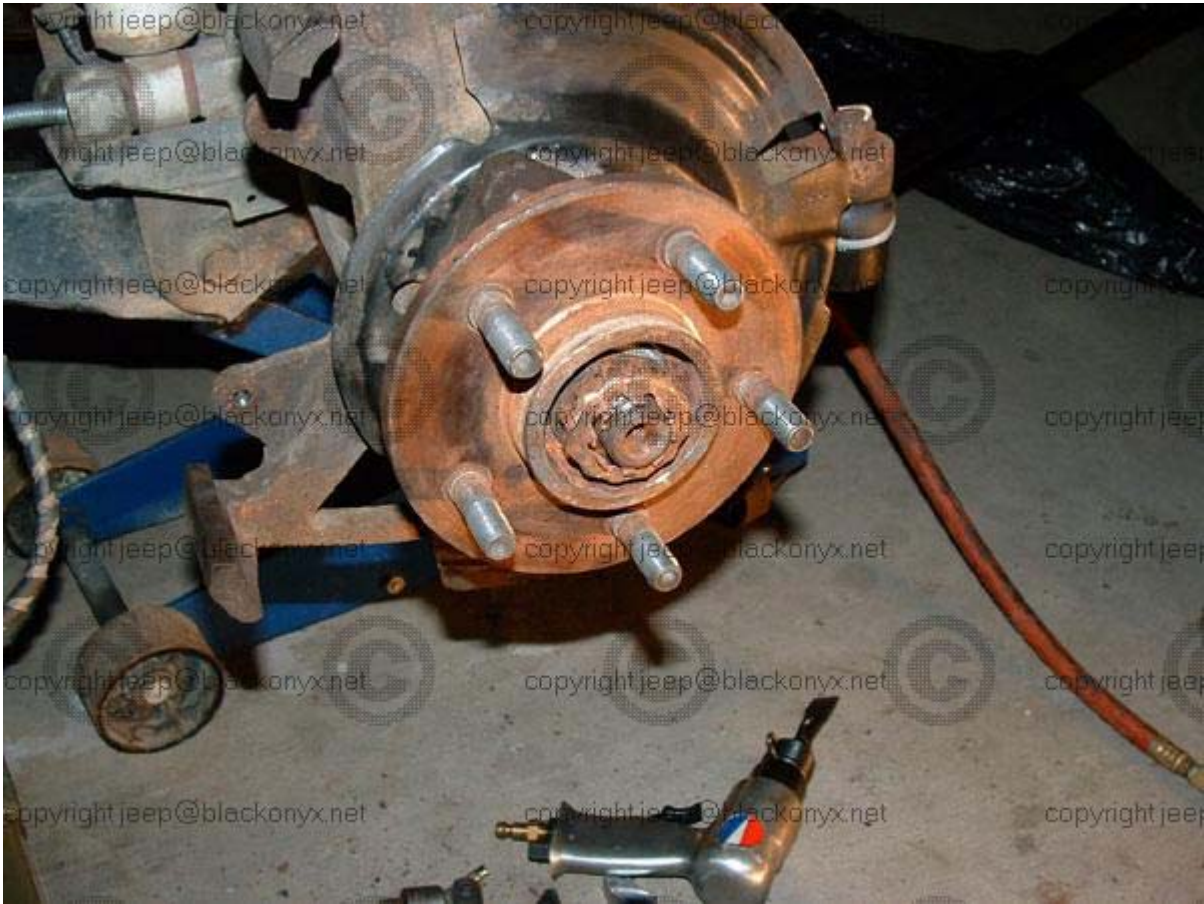
Then lock nut with cotter pin through axle half shaft:

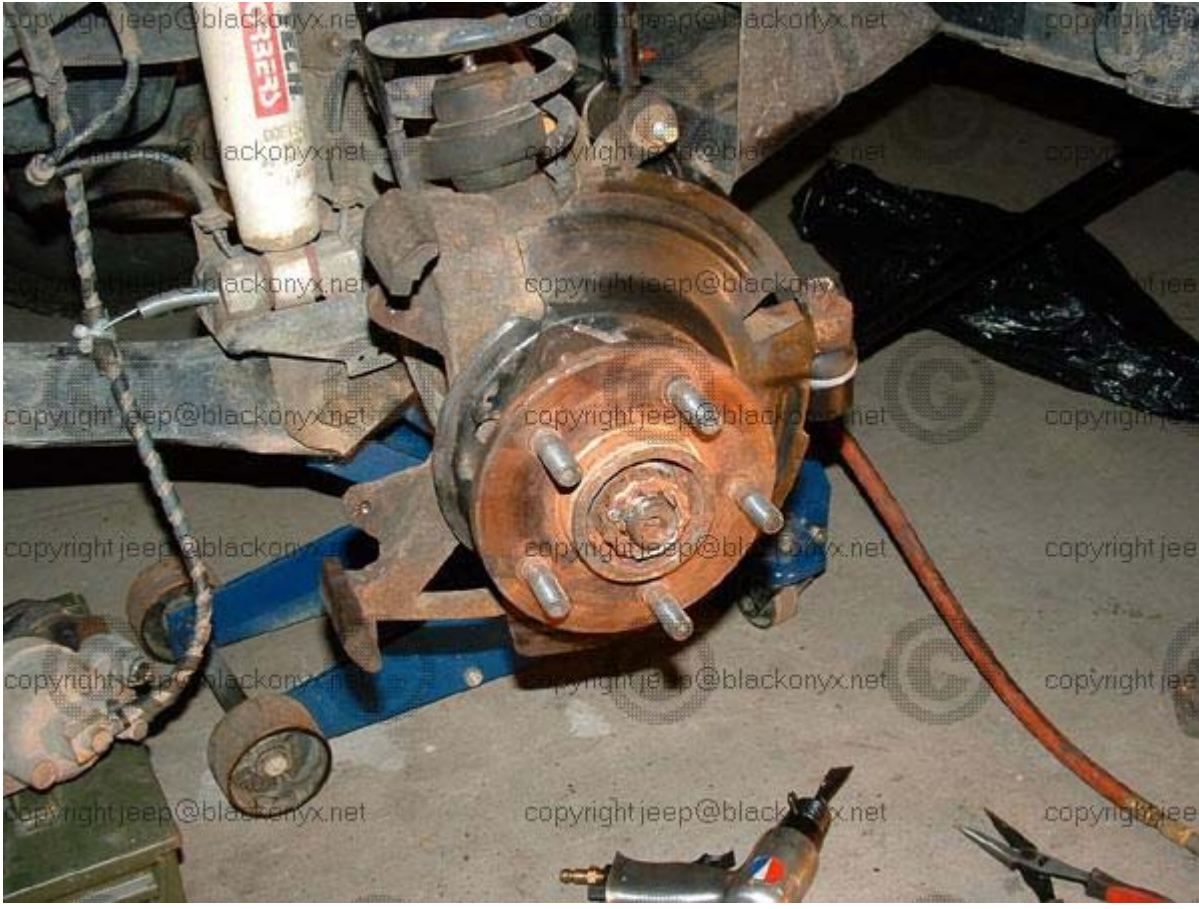
Finished with shaft install:
